CLARENDON COUNTY FIRE STATION

ASSESSMENT REPORT: EXAMINATION OF EXTERIOR CURTAIN WALL AND ROOF SYSTEMS

PREPARED BY: JEREMY TATE, FILLMORE WILSON, & MIKE HANCE

January 22, 2013

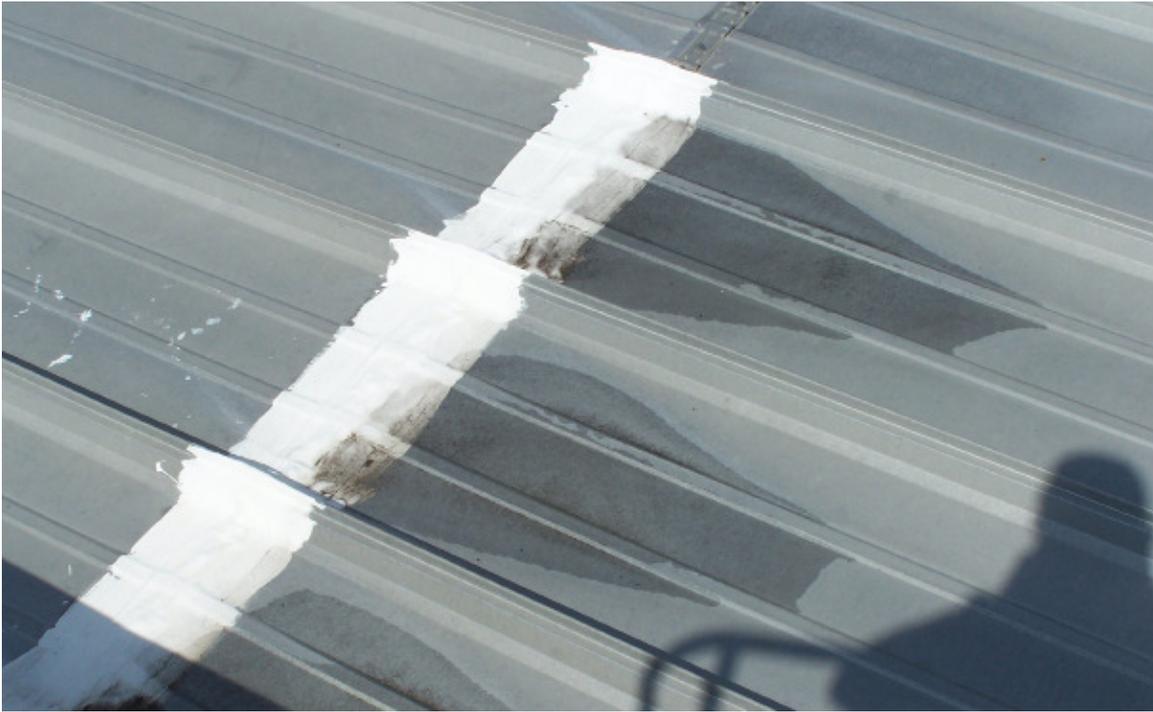
Photo 5: The joint between the panels of the metal pan roof has been coated with an elastomeric product. There is evidence on the inside of the building of leaking in this area. Also, there is evidence of water ponding on the high side of the joint

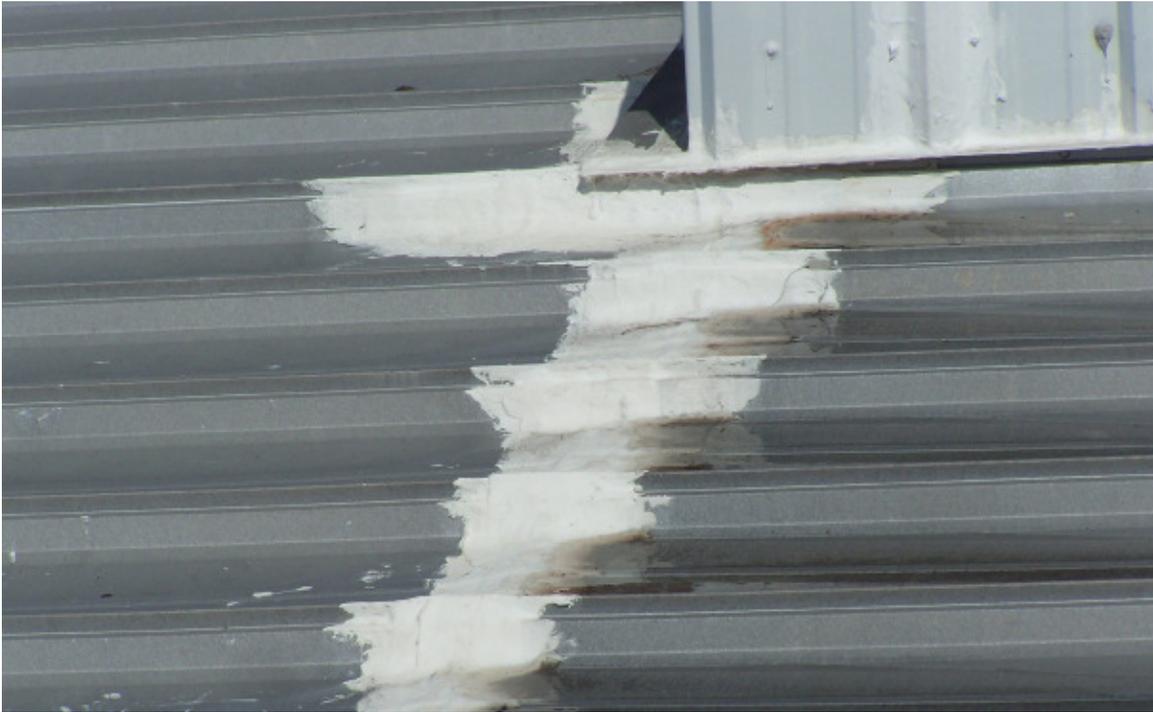
Photo 6: Elastomeric coating on another joint in the metal pan roof. There is evidence of water ponding in this area also.

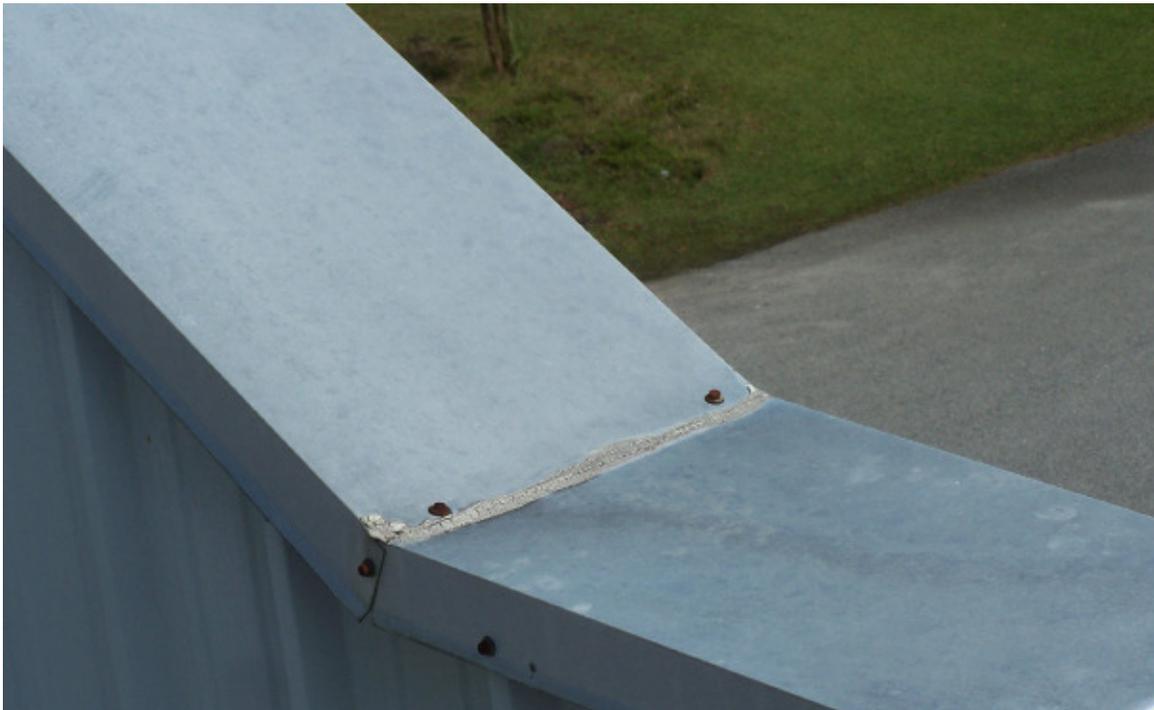
Photo 8: Metal flashing on the parapet wall above the building entry. The seams in the parapet flashing have been caulked. There is evidence that the caulk is failing and evidence in the outer wall below the parapet that water is entering behind the veneer on this wall.

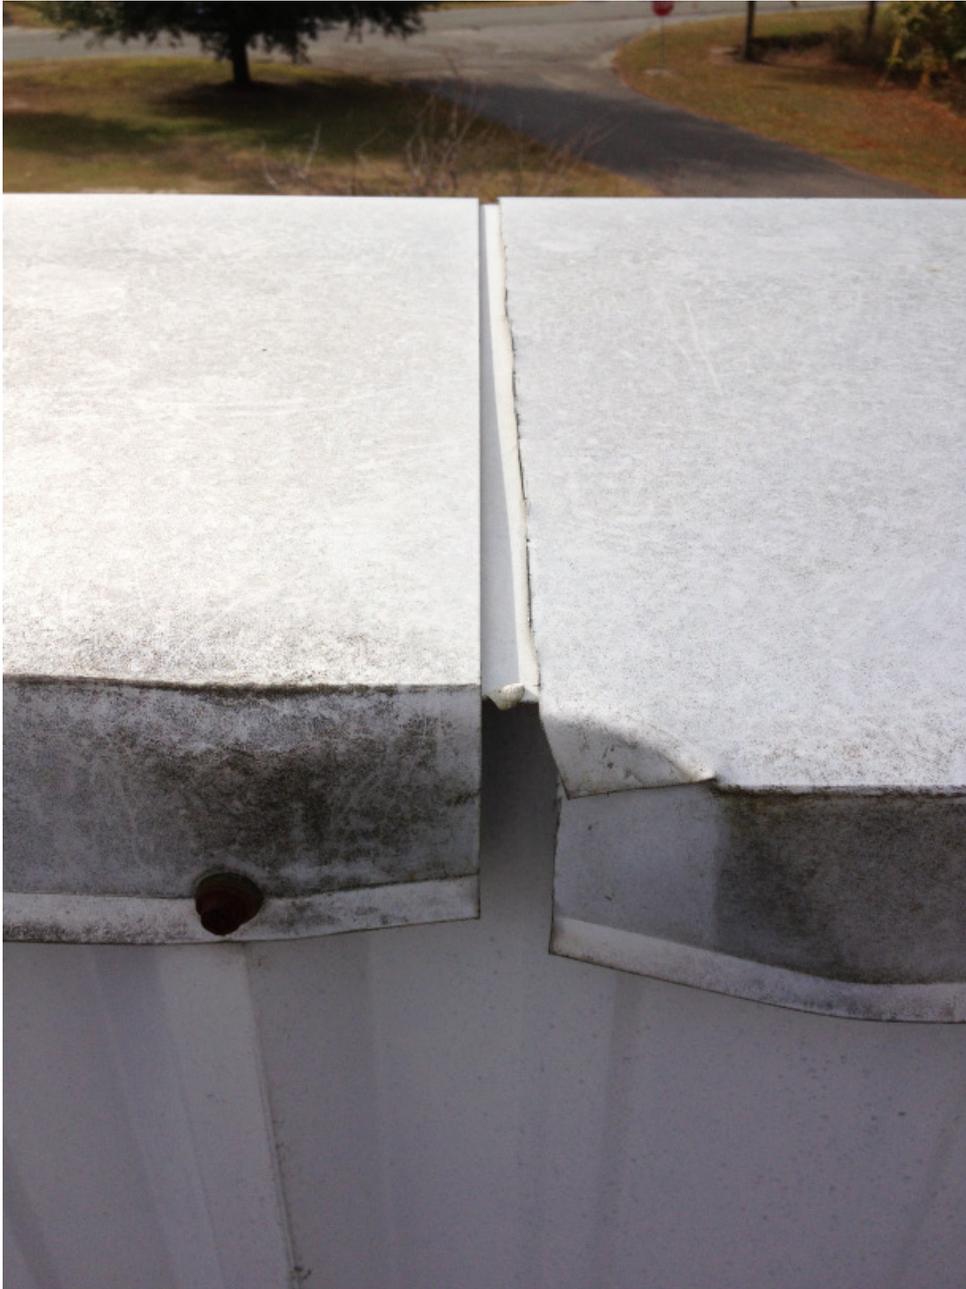
Photo 9: This photograph shows the joint between two metal parapet cap flashings. There is an open joint between the top two metal caps that has another metal flashing directly under the joint. This connection solely relies on butyl tape to make the connection watertight. The butyl tape has failed in many locations. This metal coping has experienced damage.

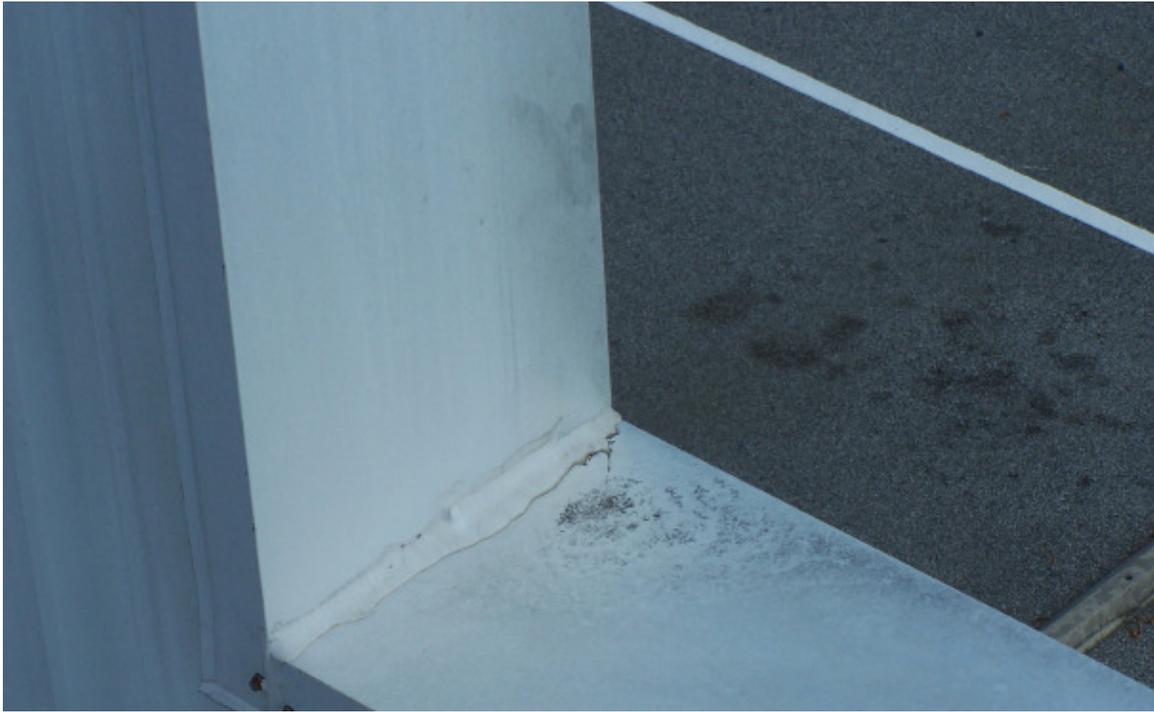
Photo 10: Metal flashing on the parapet wall above the building entry. The seams in the parapet flashing have been caulked. There is evidence that the caulk is failing and evidence in the outer wall below the parapet that water is entering behind the veneer on this wall.

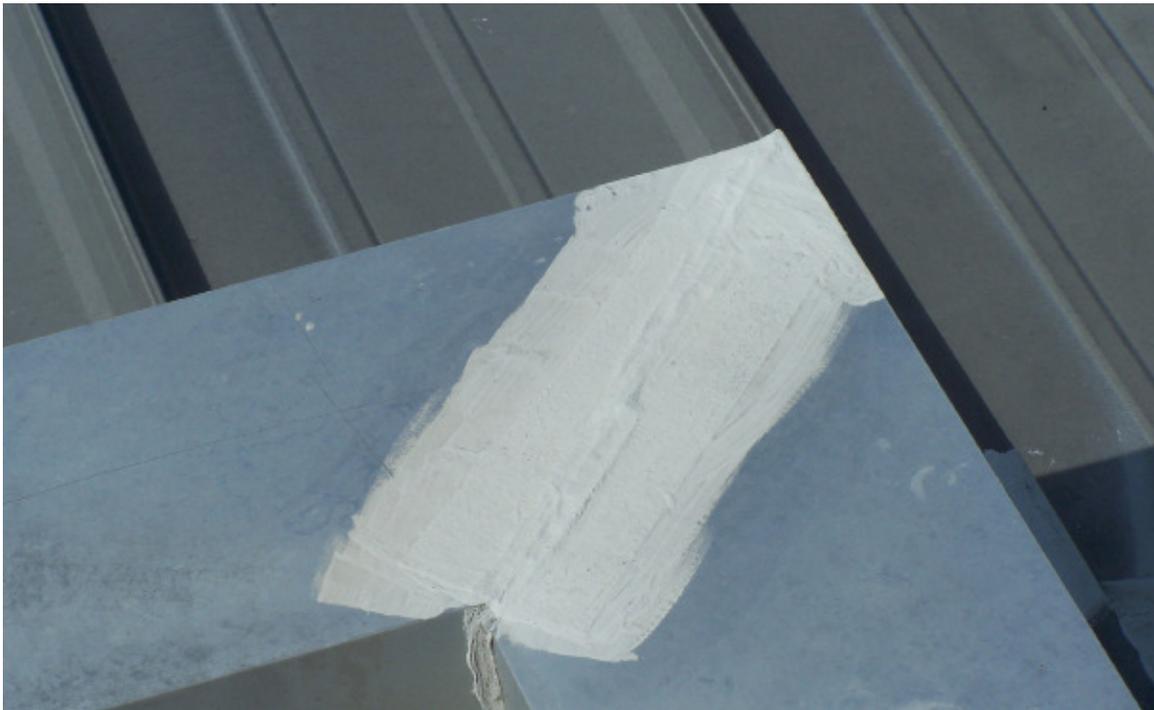
Photos 11: A number of the seams in the parapet wall flashing have been coated with an elastomeric product. Apparently the seams have been leaking at some point in the past.

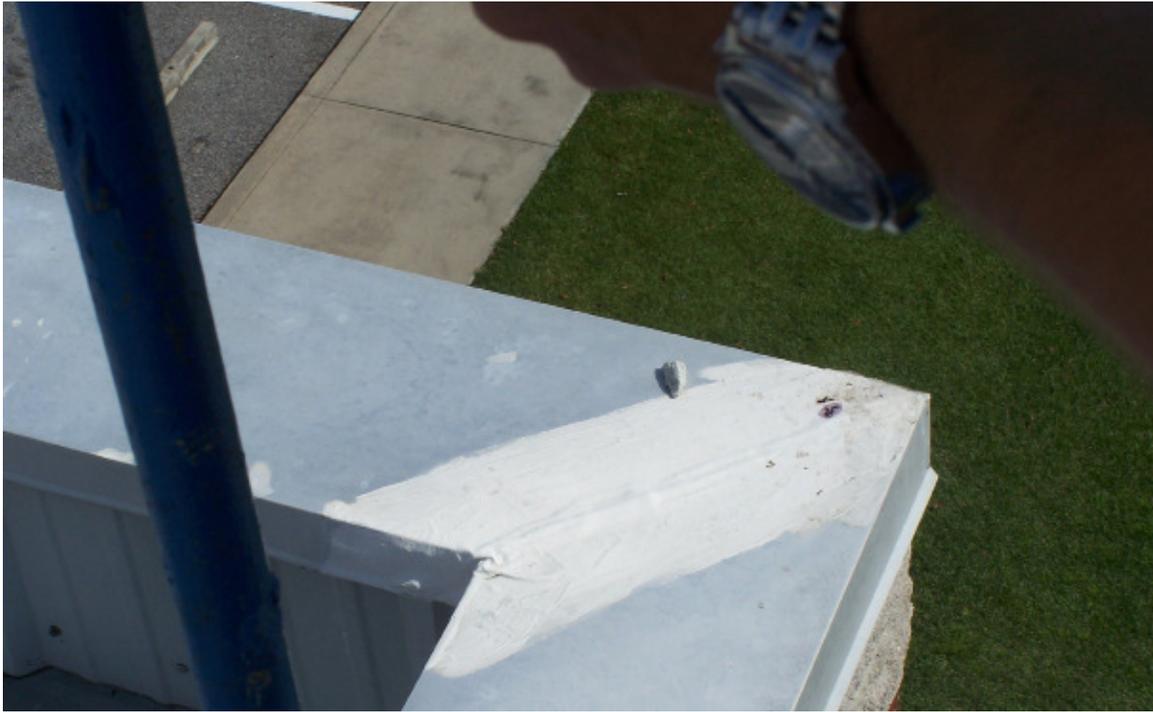
Photos 12: A number of the seams in the parapet wall flashing have been coated with an elastomeric product. Apparently the seams have been leaking at some point in the past.

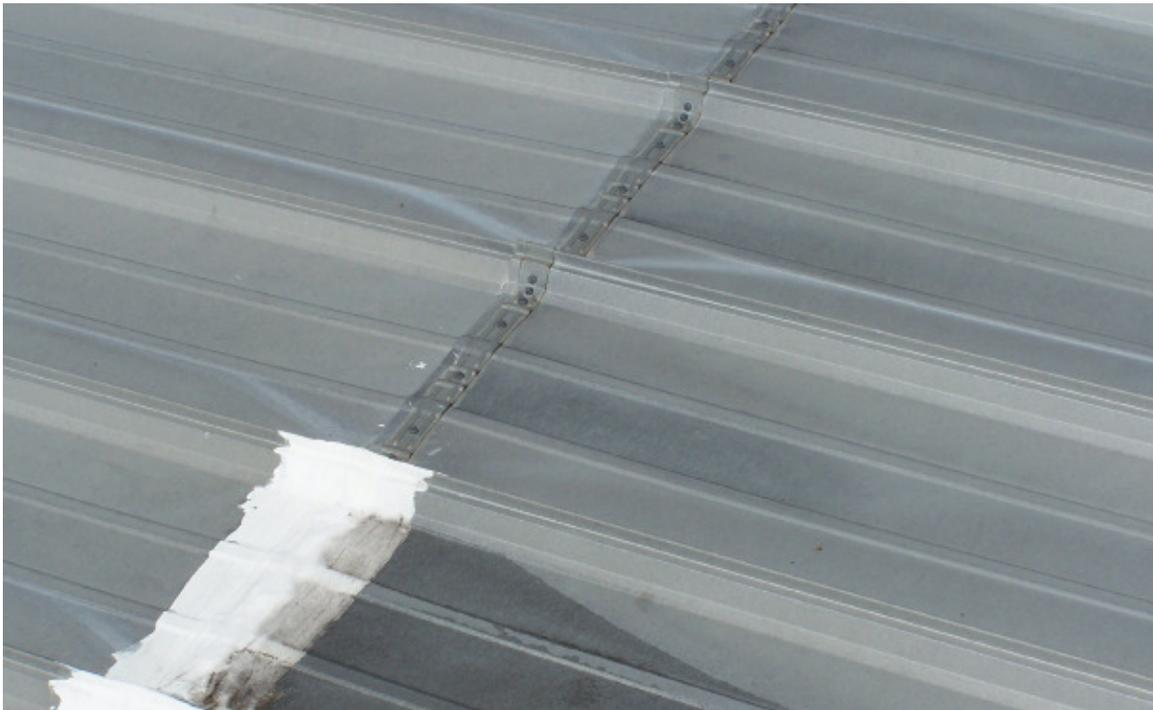
Photo 13: The metal pan roof has panels that are joined with an applied lockbar. The lockbar is face-fastened. It is evident that the roof has been leaking in a number of places at these joints. The deflection associated with the pan around these lockbars also retains water and creates ponding at the joints.

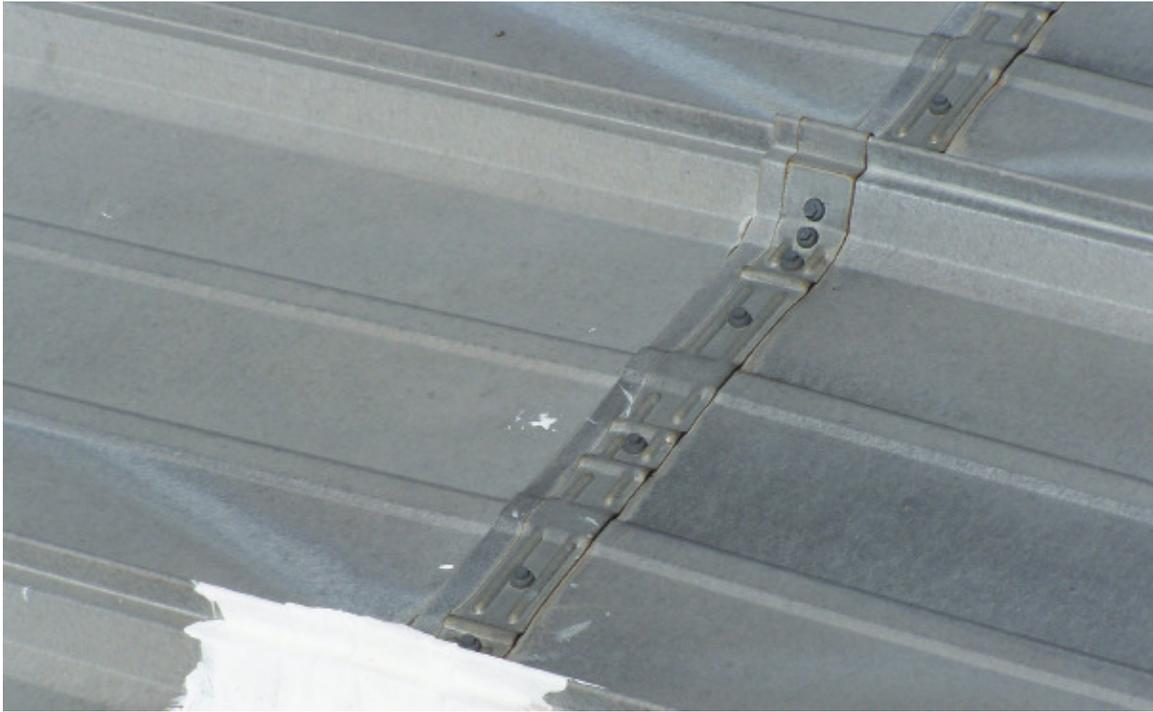
Photo 14: The metal pan roof has panels that are joined with an applied lockbar. The lockbar is face fastened. It is evident that the roof has been leaking in a number of places at these joints. The deflection associated with the pan around these lockbars also retains water and creates ponding at the joints.

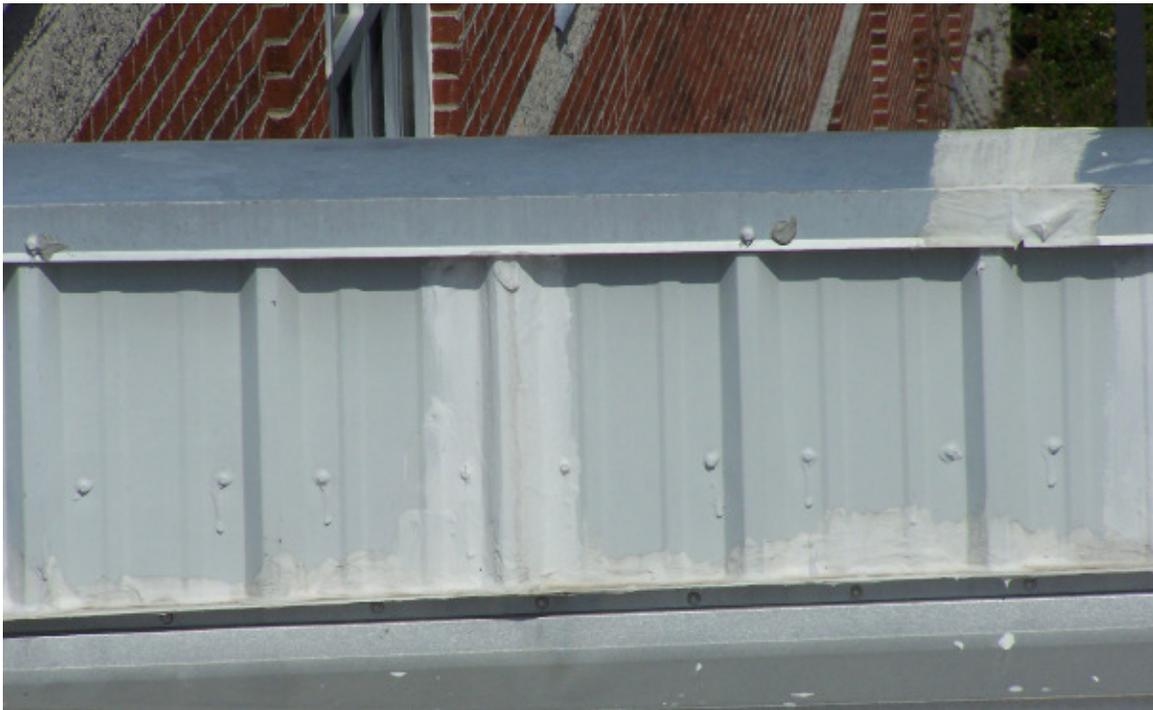
Photo 15: The inside face of the North parapet wall at the East corner. The seams on the inside face of this parapet wall have been coated with an elastomeric product. The elastomeric coating also seals the bottom of the metal panels thus trapping any moisture that entered from the top and not allowing it to escape out onto the roof.

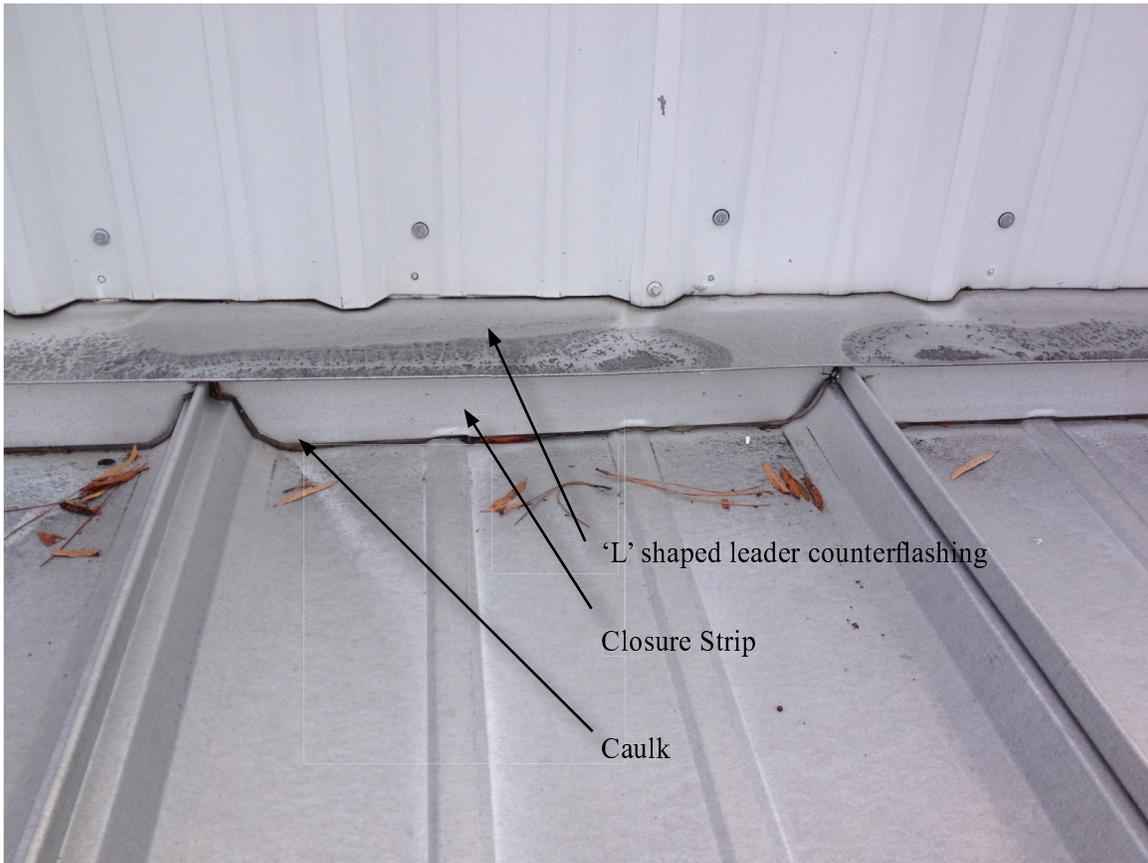
Photo 17: Closeup view of the parapet wall cladding and standing seam metal roof panel intersection. The parapet wall cladding panels are face-fastened to the parapet wall framing with sheet metal screws and rubber washers. The vertical metal cladding panels rest on a piece of 'L' shaped leader counterflashing which turns up behind the metal parapet cladding. The 'L' shaped piece of leader counterflashing flashes over the metal standing seam panels. There is evidence that the seams between the vertical metal parapet wall cladding leaks as well as many of the face-fasteners. The 'L' shaped piece of leader counterflashing also leaks at the seams between individual segments of counterflashing. Also, note the caulking at the closure strip in the metal standing seam panel. The caulking is showing signs of failure which will allow water into the roof assembly.

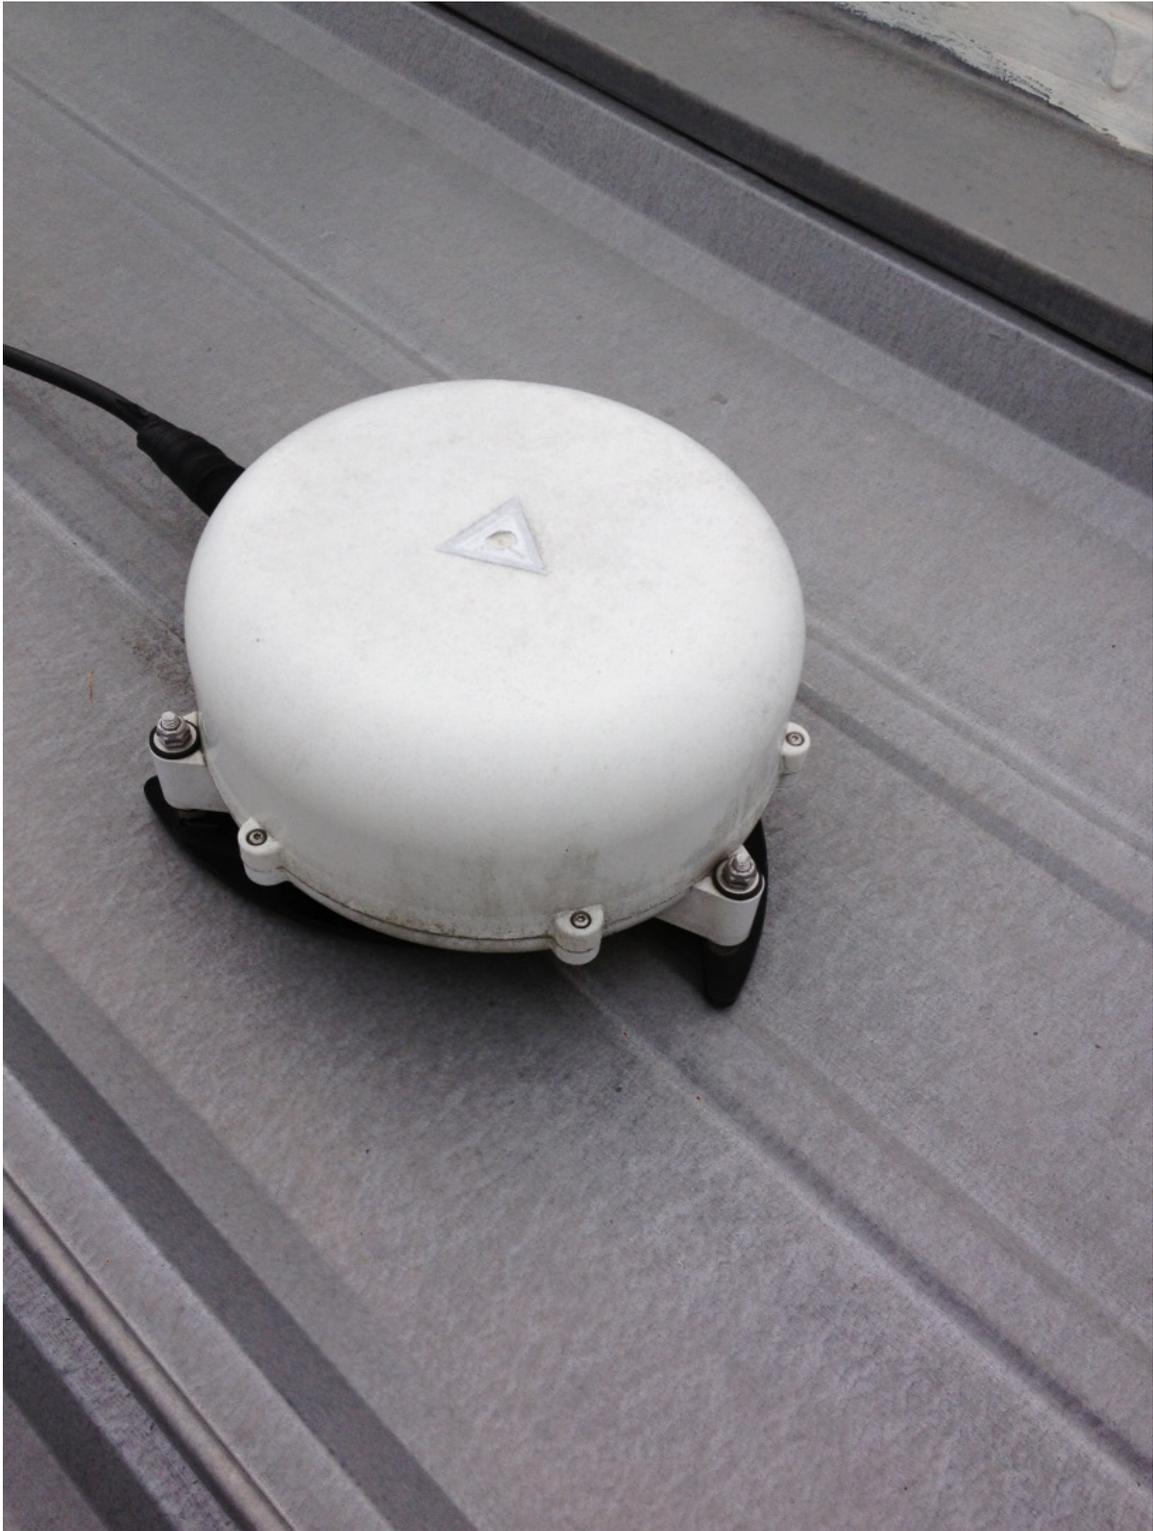
Photo 18: This photograph shows a component of the satellite dish that is fastened directly to the metal standing seam panel. This face-fastened connection provides a direct avenue for water to enter the facility. This component should be relocated and mounted to the face of the masonry wall or mounted so that it is elevated off the surface of the standing seam metal. The elevated metal support may be attached to the standing seam so that water can freely move under this component. Holes in panel should be patched with new metal panel which is attached with face-fastened gasketed screws and appropriate sealant.

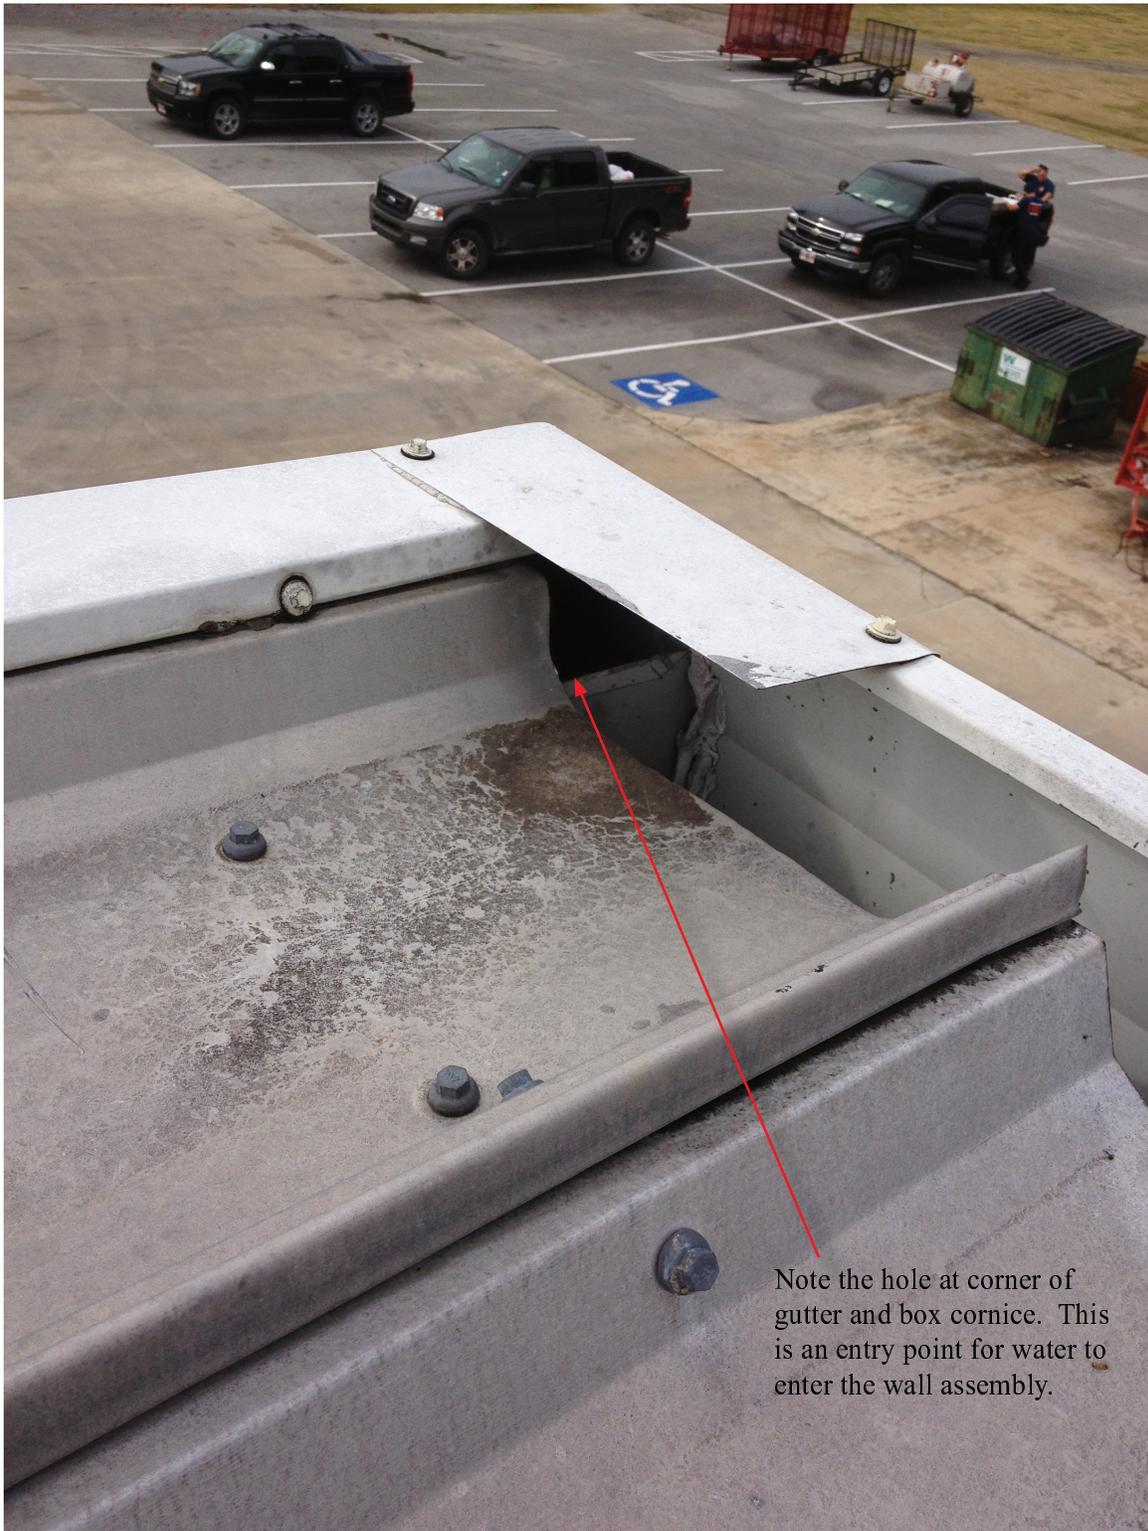
Note the hole at corner of gutter and box cornice. This is an entry point for water to enter the wall assembly.

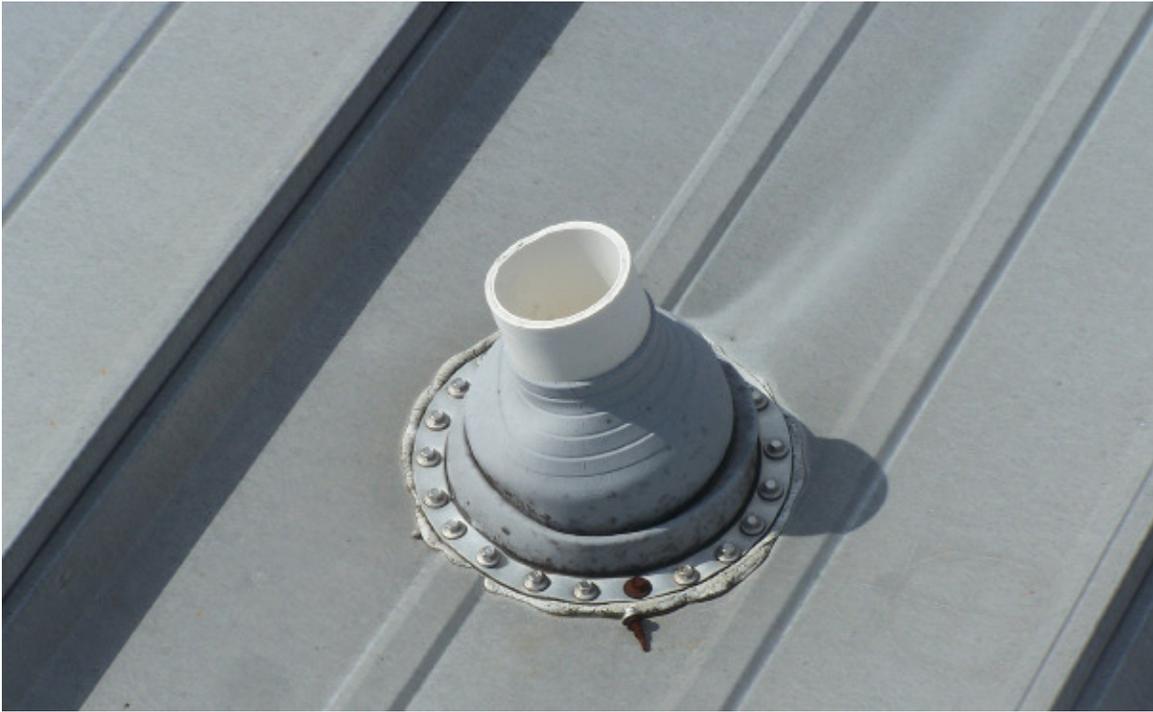
Photo 20: This roof penetration is leaking. The calk on the ring has failed and the penetration is leaking between the ring and the metal pan roof. This condition is typical of all roof penetrations.

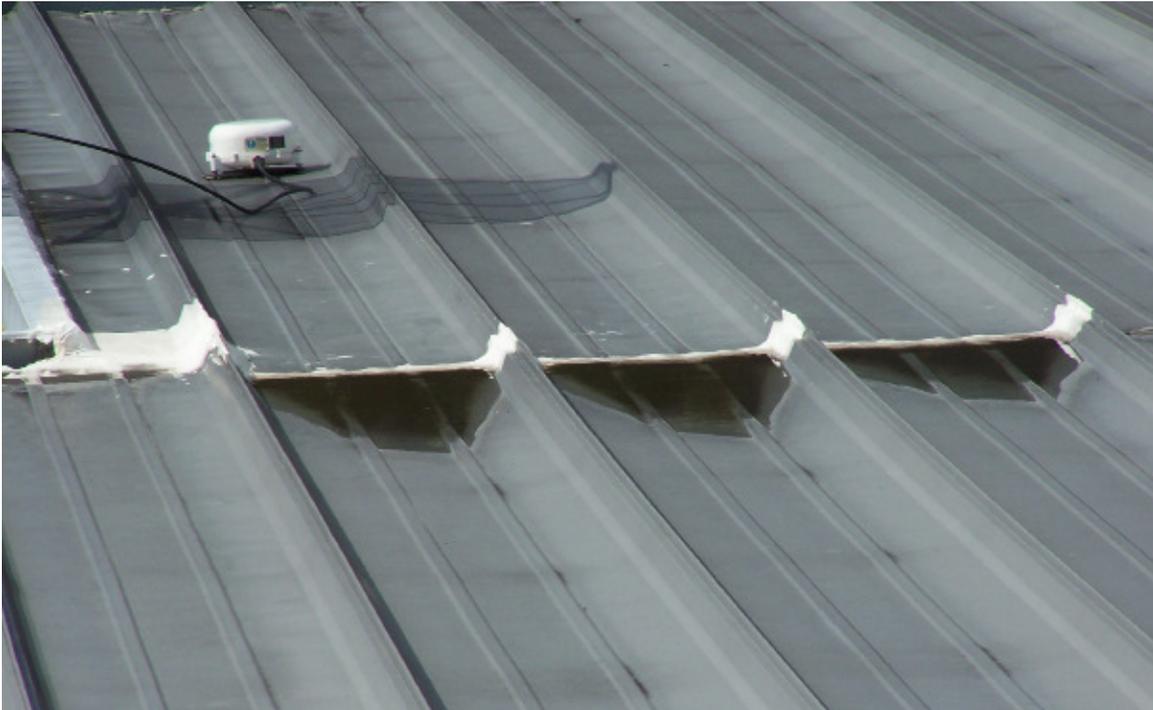
Photo 21: Water is ponding at the seams in the metal pan roof. The seams have been coated with an elastomeric product in an attempt to prevent the roof from leaking.

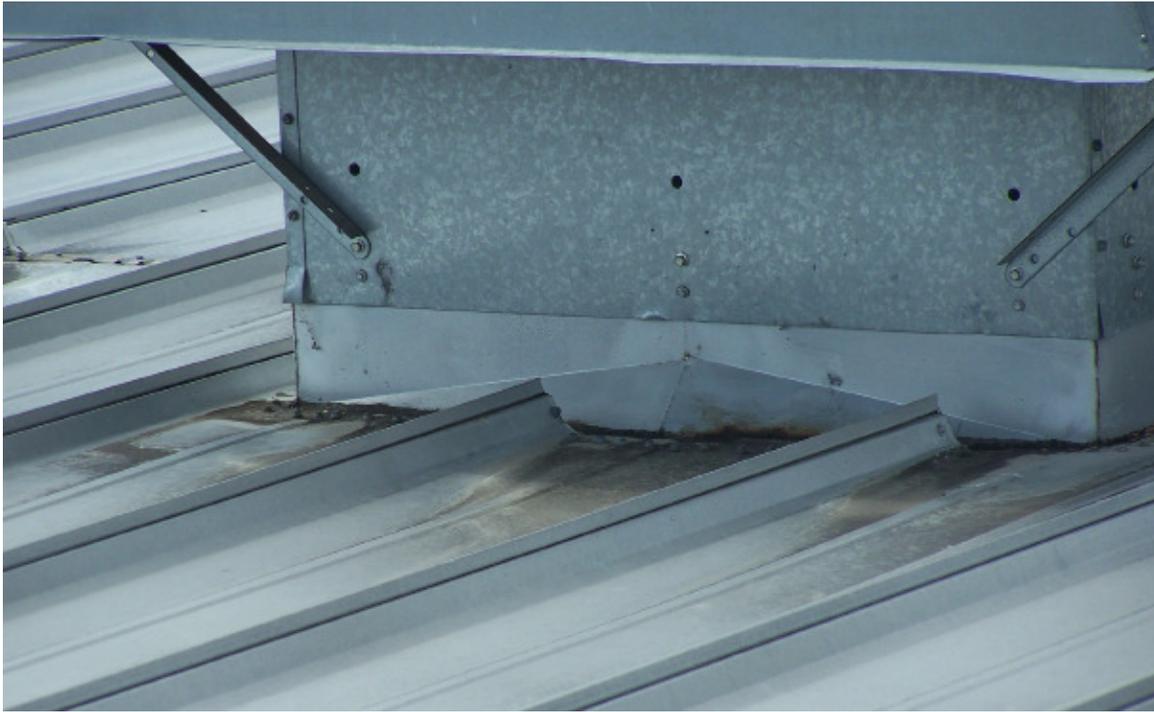
Photo 22: There is evidence that water ponds on the backside, i.e. the high side (east) of all of the roof ventilators. There is also evidence that the building leaks at these penetrations. There is a slight cricket behind each roof ventilator, but it appears not to be extensive enough to prevent ponding.

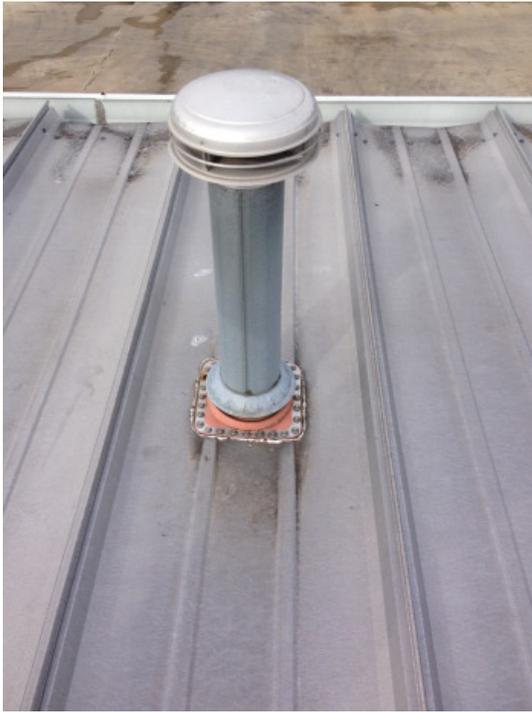
Photo 24: There is evidence that water ponds on the backside (east side), i.e. the high side of all of the roof penetrations. There is also evidence that the building leaks at these penetrations.

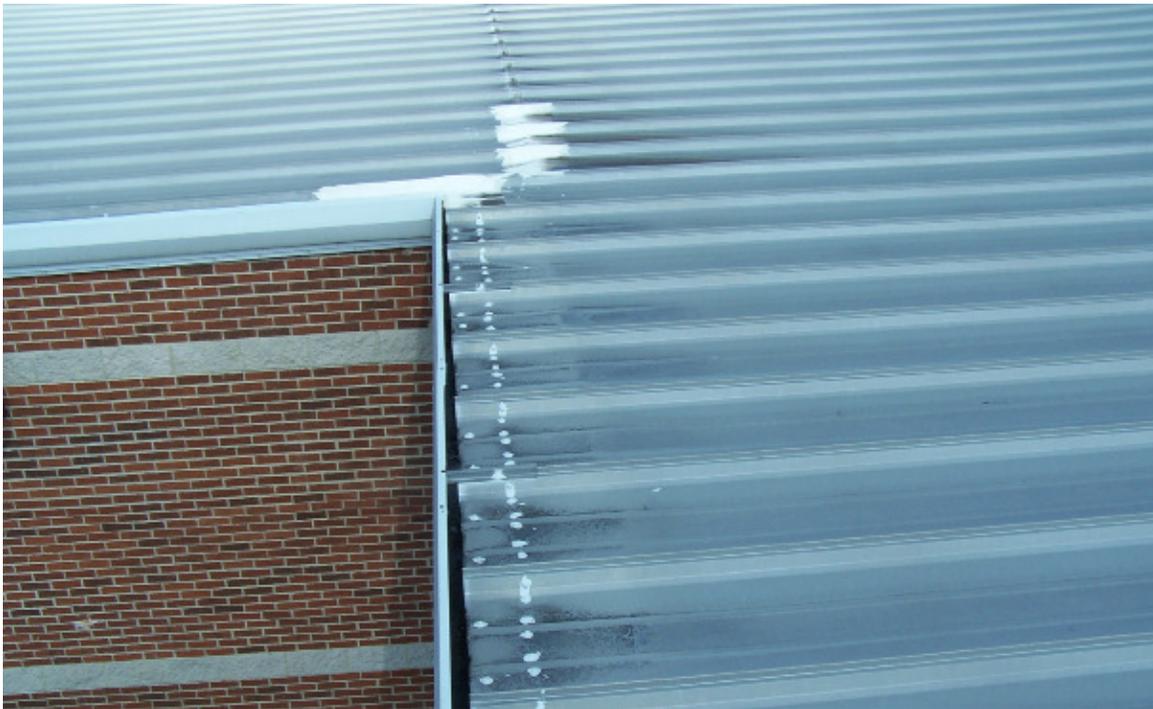
Photo 25: The screws in the edge of the metal pan roof at the gutter on the West side have been coated with elastomeric or caulk. There is evidence that water ponds at the edge of the roof as it runs into the gutter, thus allowing any fasteners that are not secure to let water into the structure behind the brick veneer. There is evidence of ponding all along the edge of the roof at the gutter. This may indicate that the roof slopes slightly up at the edge or that in a very hard rain the gutter is insufficient to carry off the water and the water backs up onto the roof as it spills out of the gutter. In either circumstance, the fasteners, if not completely secure, would allow water into the structure behind the brick veneer.

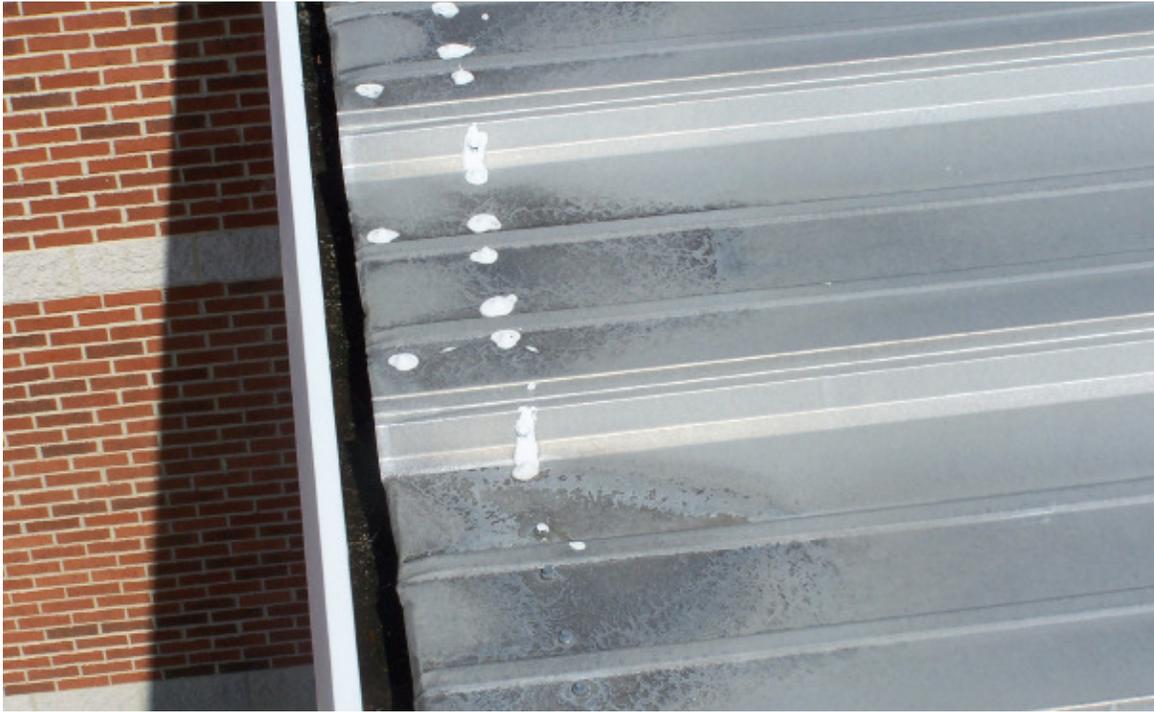
Photo 26: Evidence of ponding at the edge of the roof at the gutter. The water stains in this area could be the result a slight upturn in the roof. The fact that the gutter, in a hard rain, may be unable to carry the water off means that the water backs up onto the roof as the gutter overflows.

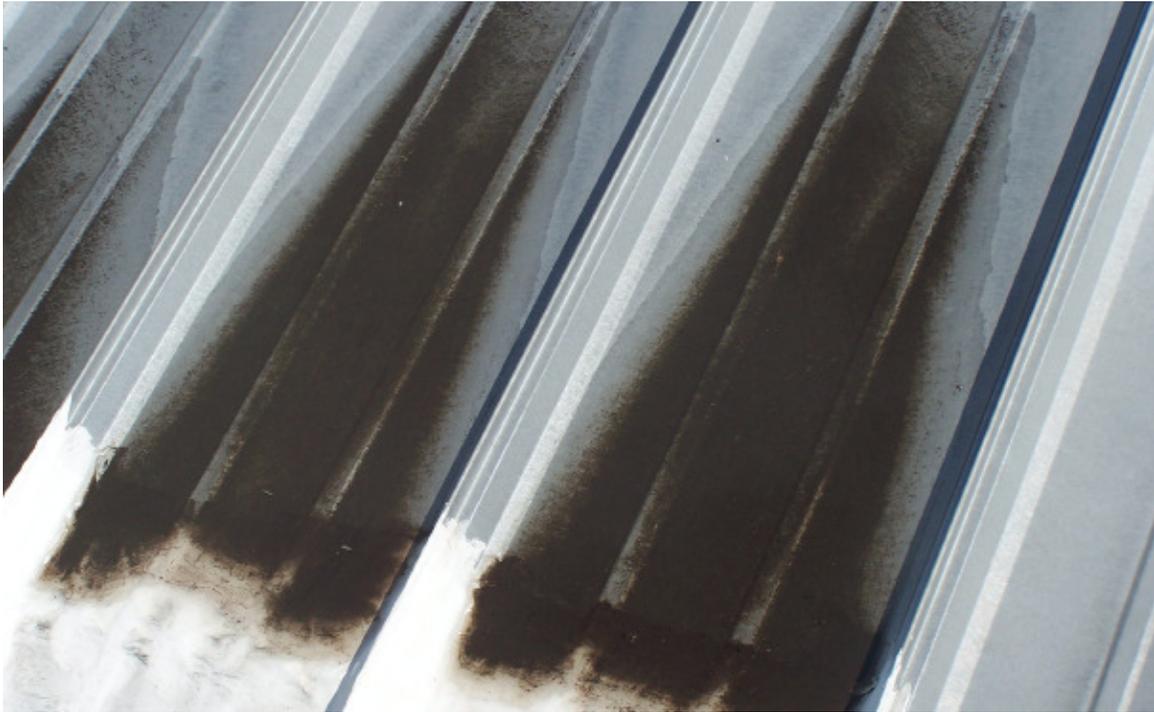
Photo 27: Ponding at the joints in the metal pan roof.

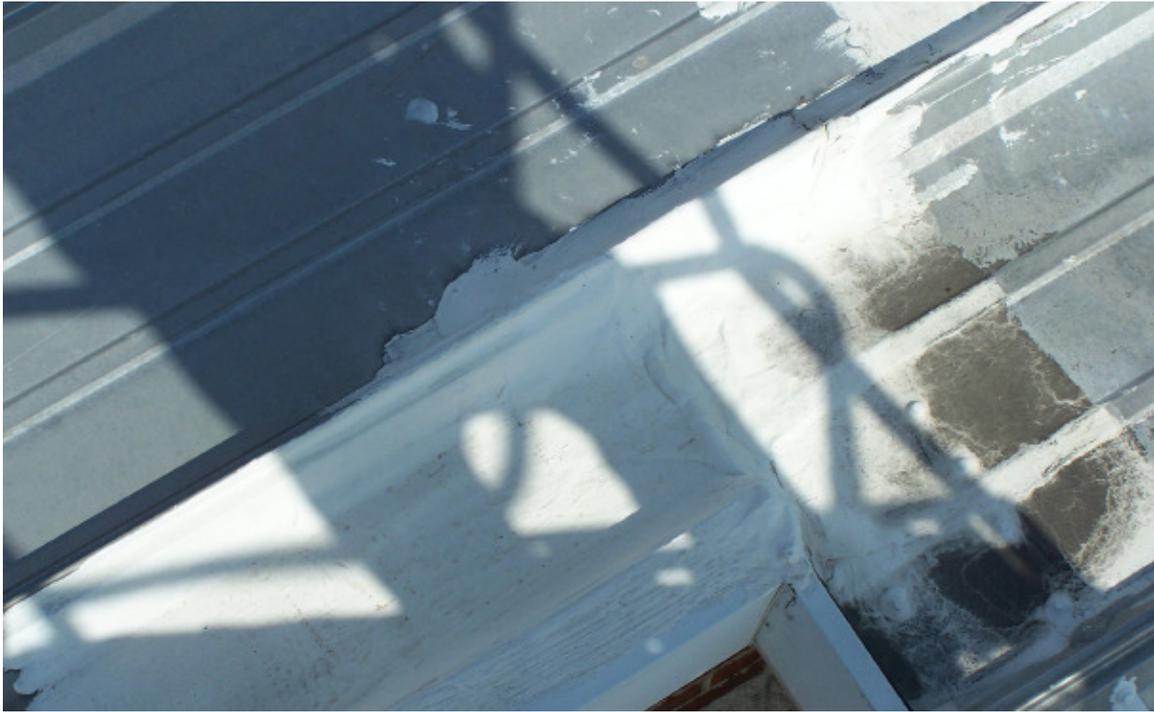
Photo 28: Elastomeric coating applied to the roof in the South West corner. There is evidence that water ponds in this area and the roof has leaked. The elastomeric coating is an attempt to prevent water intrusion in this area.

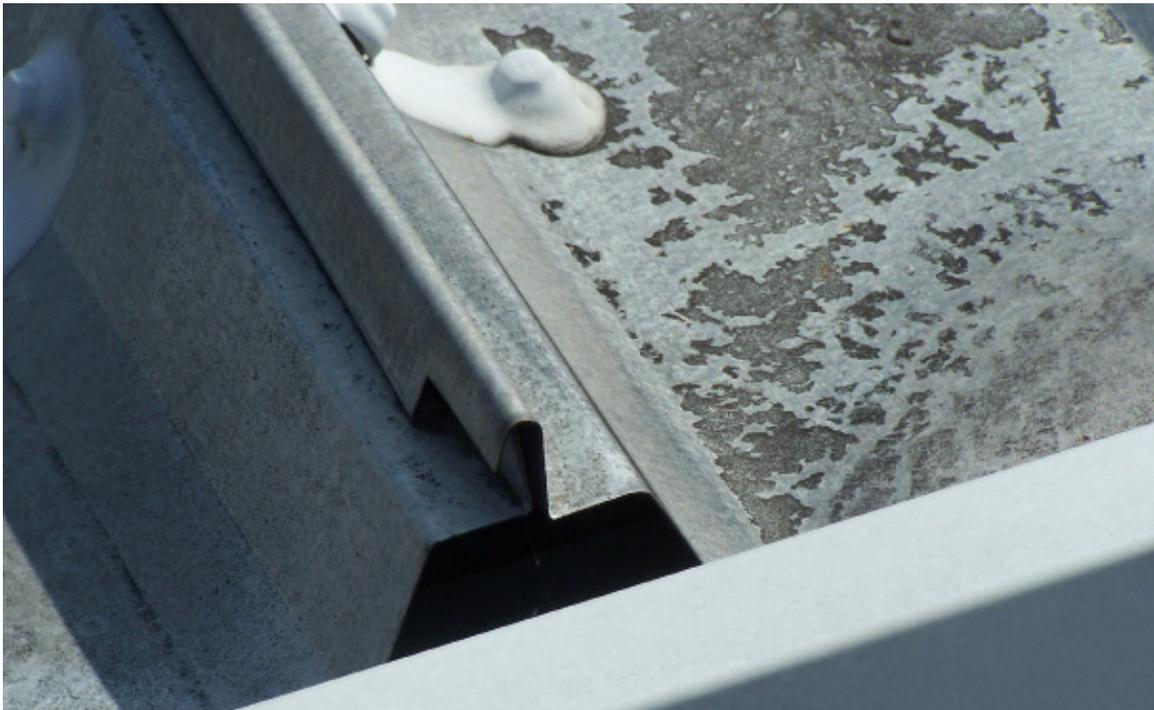
Photo 29: This photo shows the ends of the ridges in the metal roof panels at the edge of the roof at the gutter. The ends are open at the gutter. If water backs up onto the roof from a full gutter, that water could enter the open ends of the seams and flow directly into the building and behind the brick veneer.

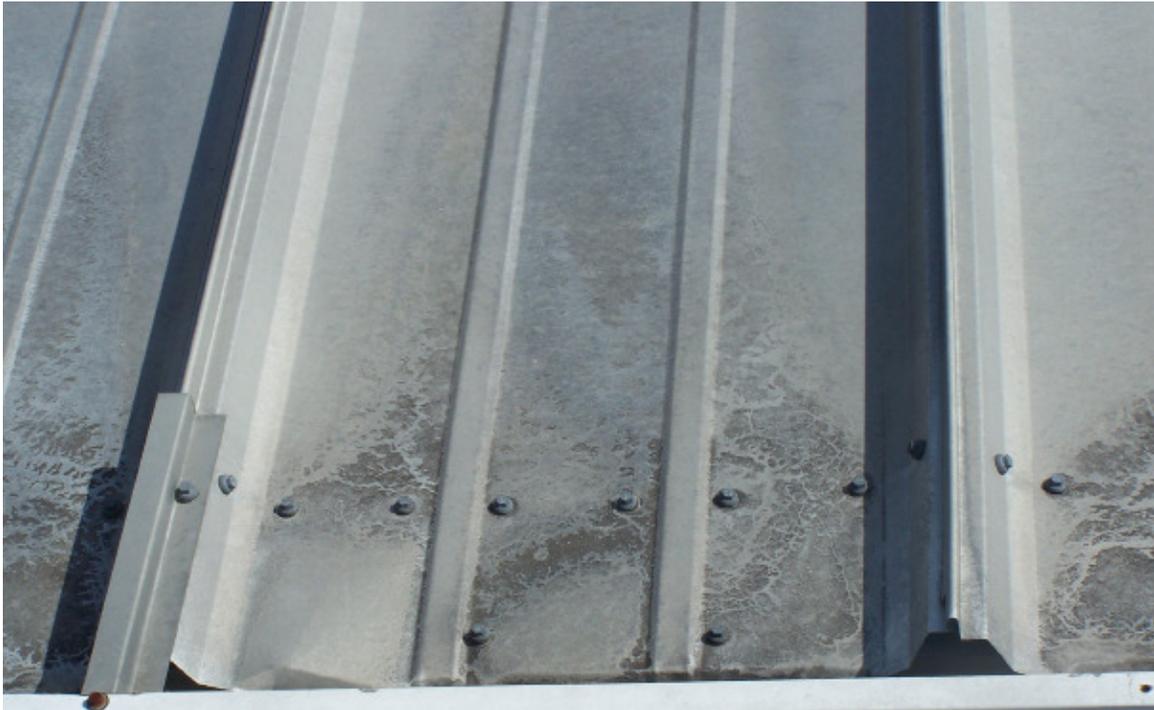
Photo 30: This is the edge of the roof at the gutter along the West wall on the portion of the building adjacent to the Fire Department garage bays. The condition in this area is the same as above the garage bays. There is evidence of water ponding and standing all along the edge of the roof. This can result in water intrusion into the structure at any unsecured fasteners or at the open panel edges. See also Photo 31 as example.
