CLARENDON COUNTY FIRE STATION

ASSESSMENT REPORT: EXAMINATION OF EXTERIOR CURTAIN WALL AND ROOF SYSTEMS

PREPARED BY: JEREMY TATE, FILLMORE WILSON, & MIKE HANCE

January 22, 2013

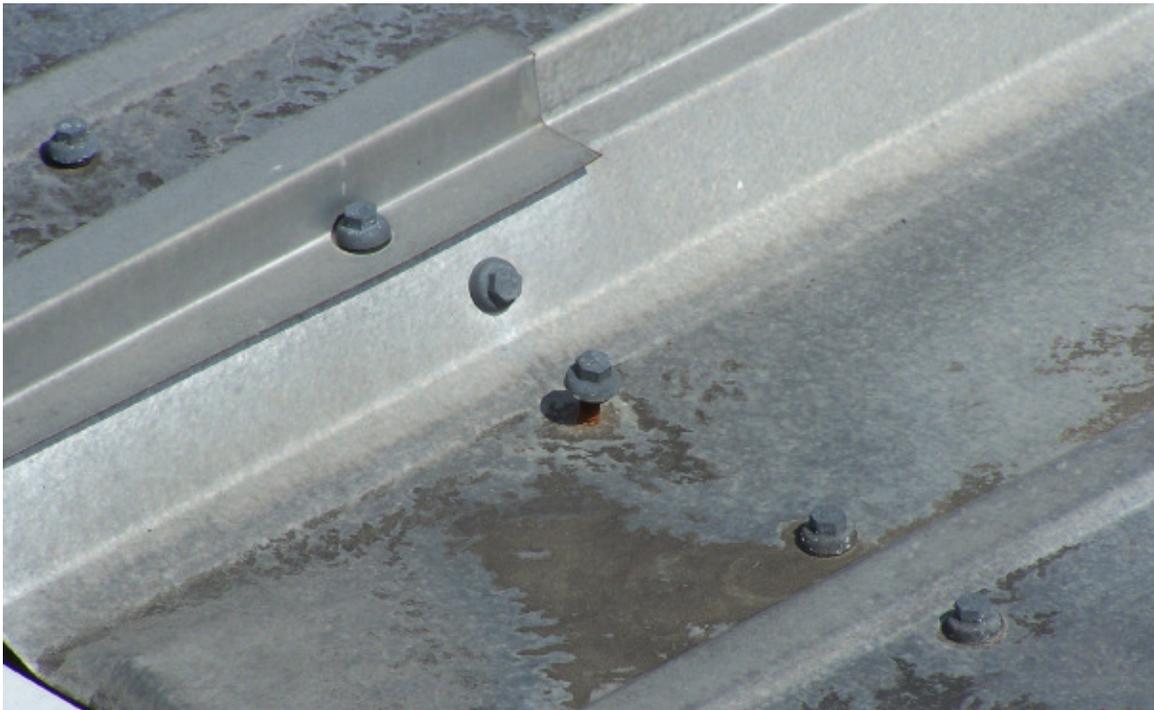
Photo 31: This photograph shows the condition of the fasteners at the edge of the metal standing seam roof panels where they meet the box gutter. Note the loosed fastener, which is a direct avenue for water to enter the roof system.

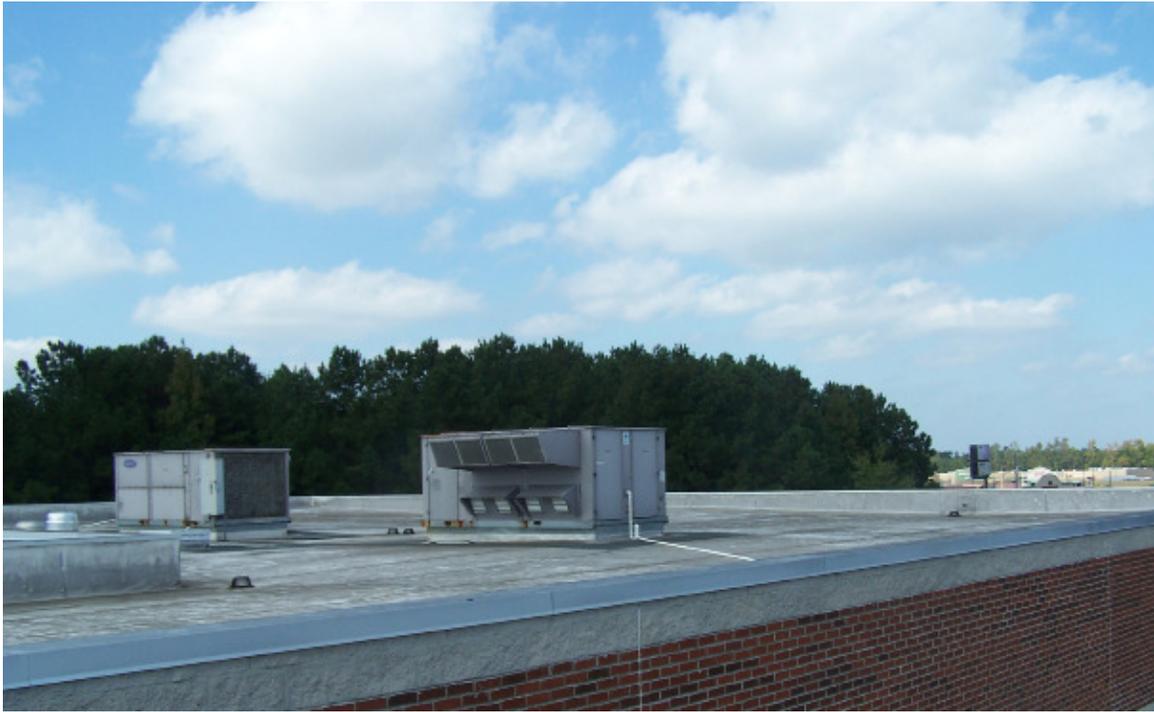
Photo 32: PVC roof above the Sheriffs Building. The roof requires cleaning.

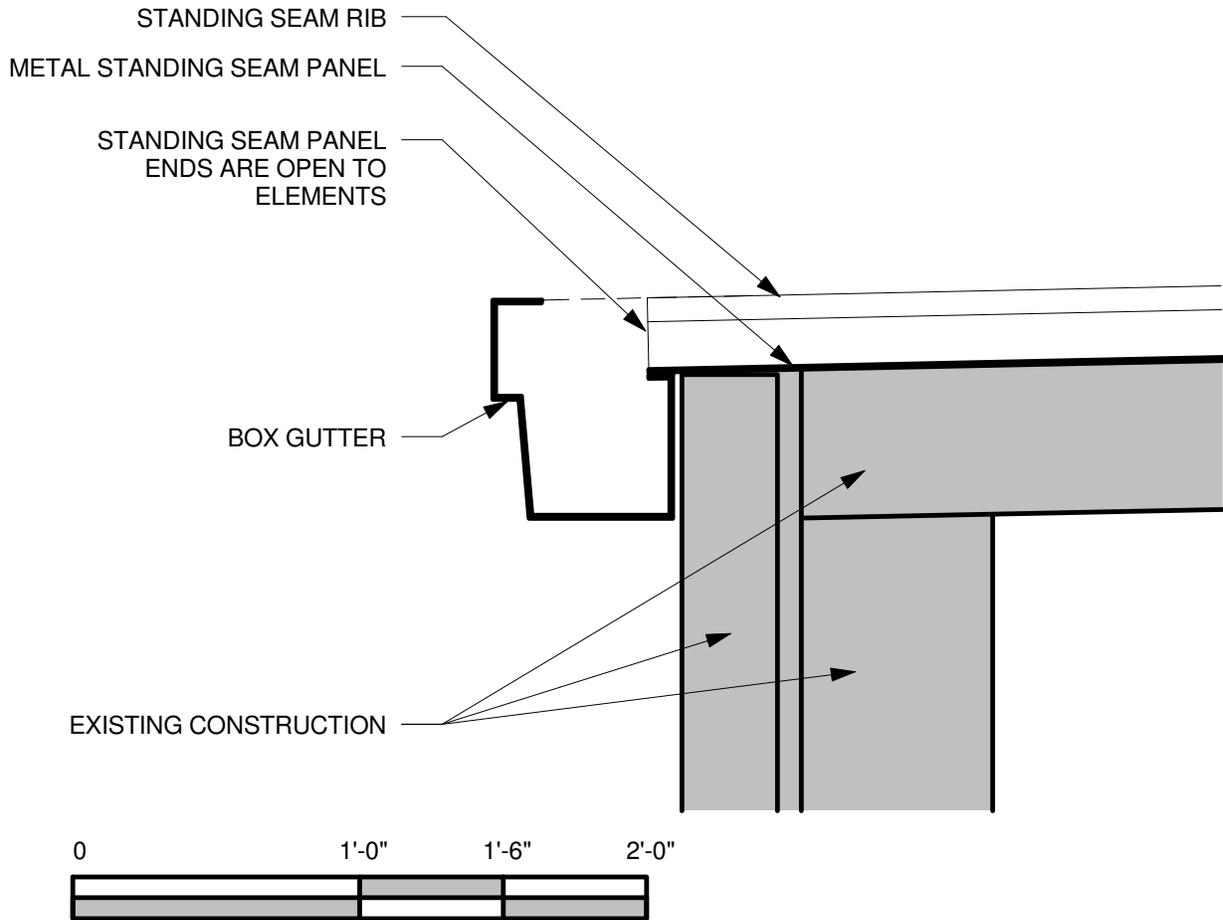
① EXISTING GUTTER CONDITION
 1 1/2" = 1'-0"

The surface attached box gutter has been installed along the western edge of the roof. The top of the gutter is set higher than the lowest pan of the standing seam metal roof panels. At the gutter, the edge of the metal standing seam roof panels do not have a closure strip and allow free movement of air and moisture under the metal standing seam panel and into the wall assembly. There is evidence that the gutters may have backed up during heavy rain events in the past. Such a backup of the gutter, would result in water standing on the roof edge and water would enter the building via the fasteners and the lack of a proper closure strip.

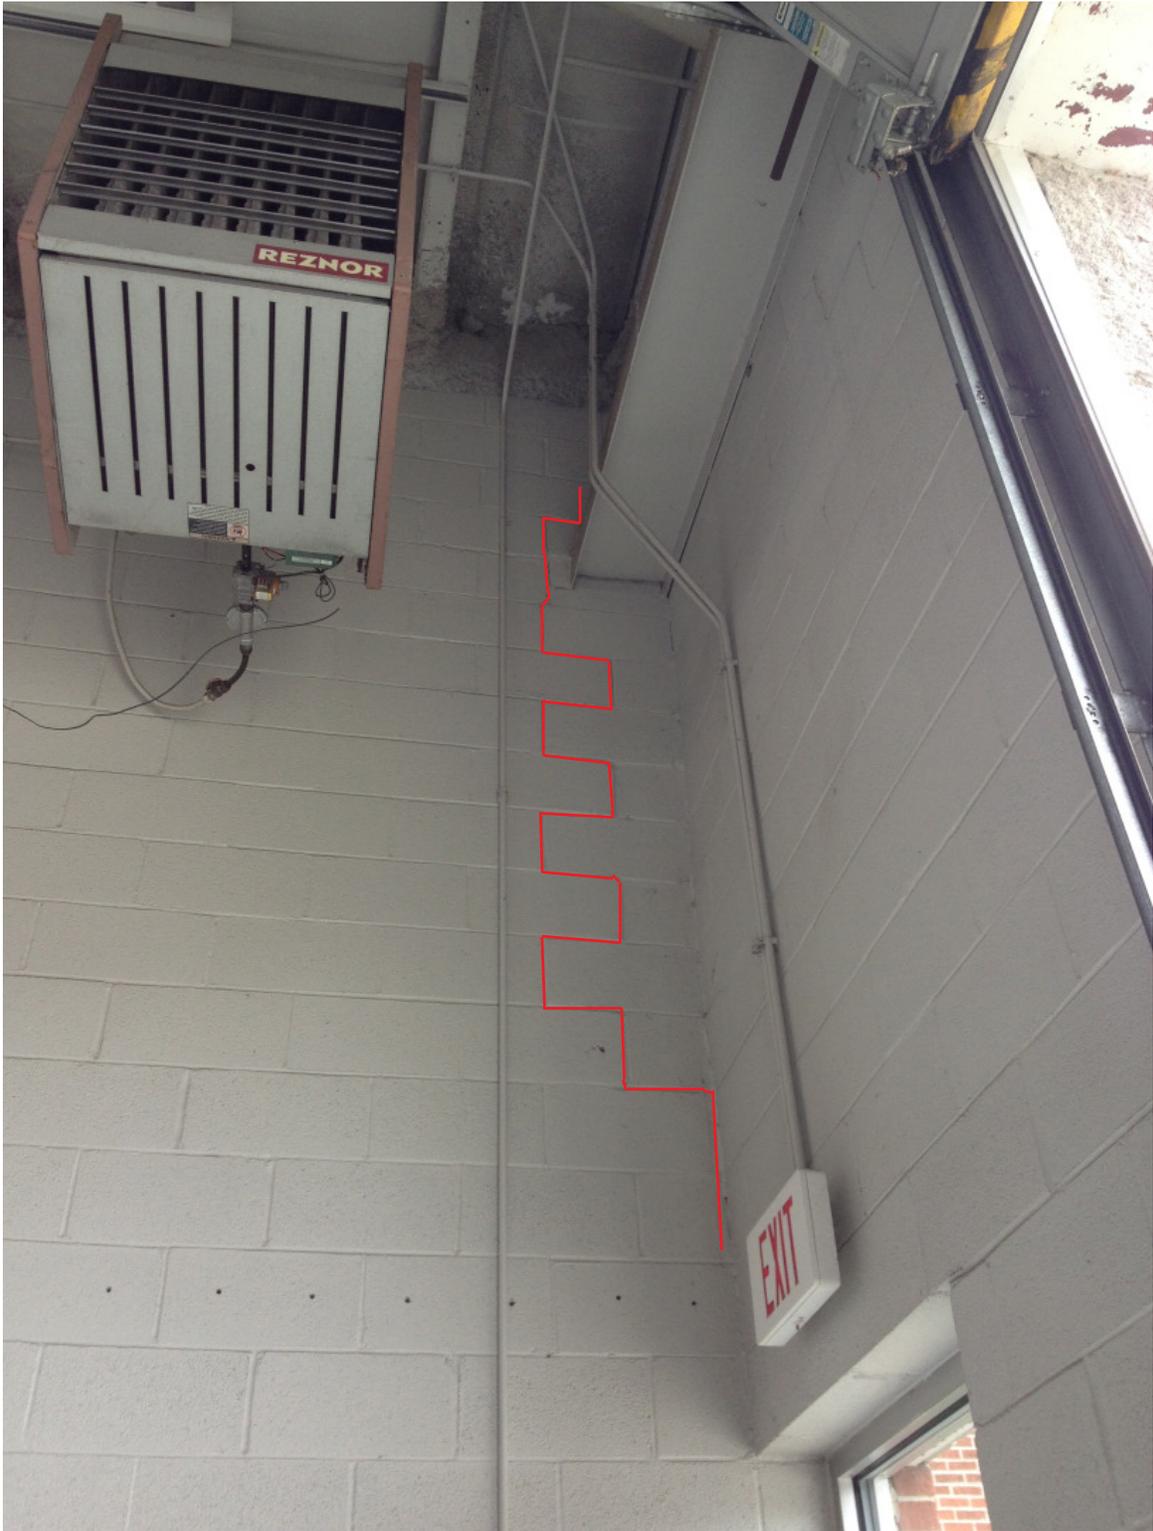
Photo 43: Interior photograph on Northeast quadrant of truck bay. The red line highlights the existing crack in the mortar joint of the 12" concrete masonry block wall that separates the truck bays from the fire station offices and main lobby.

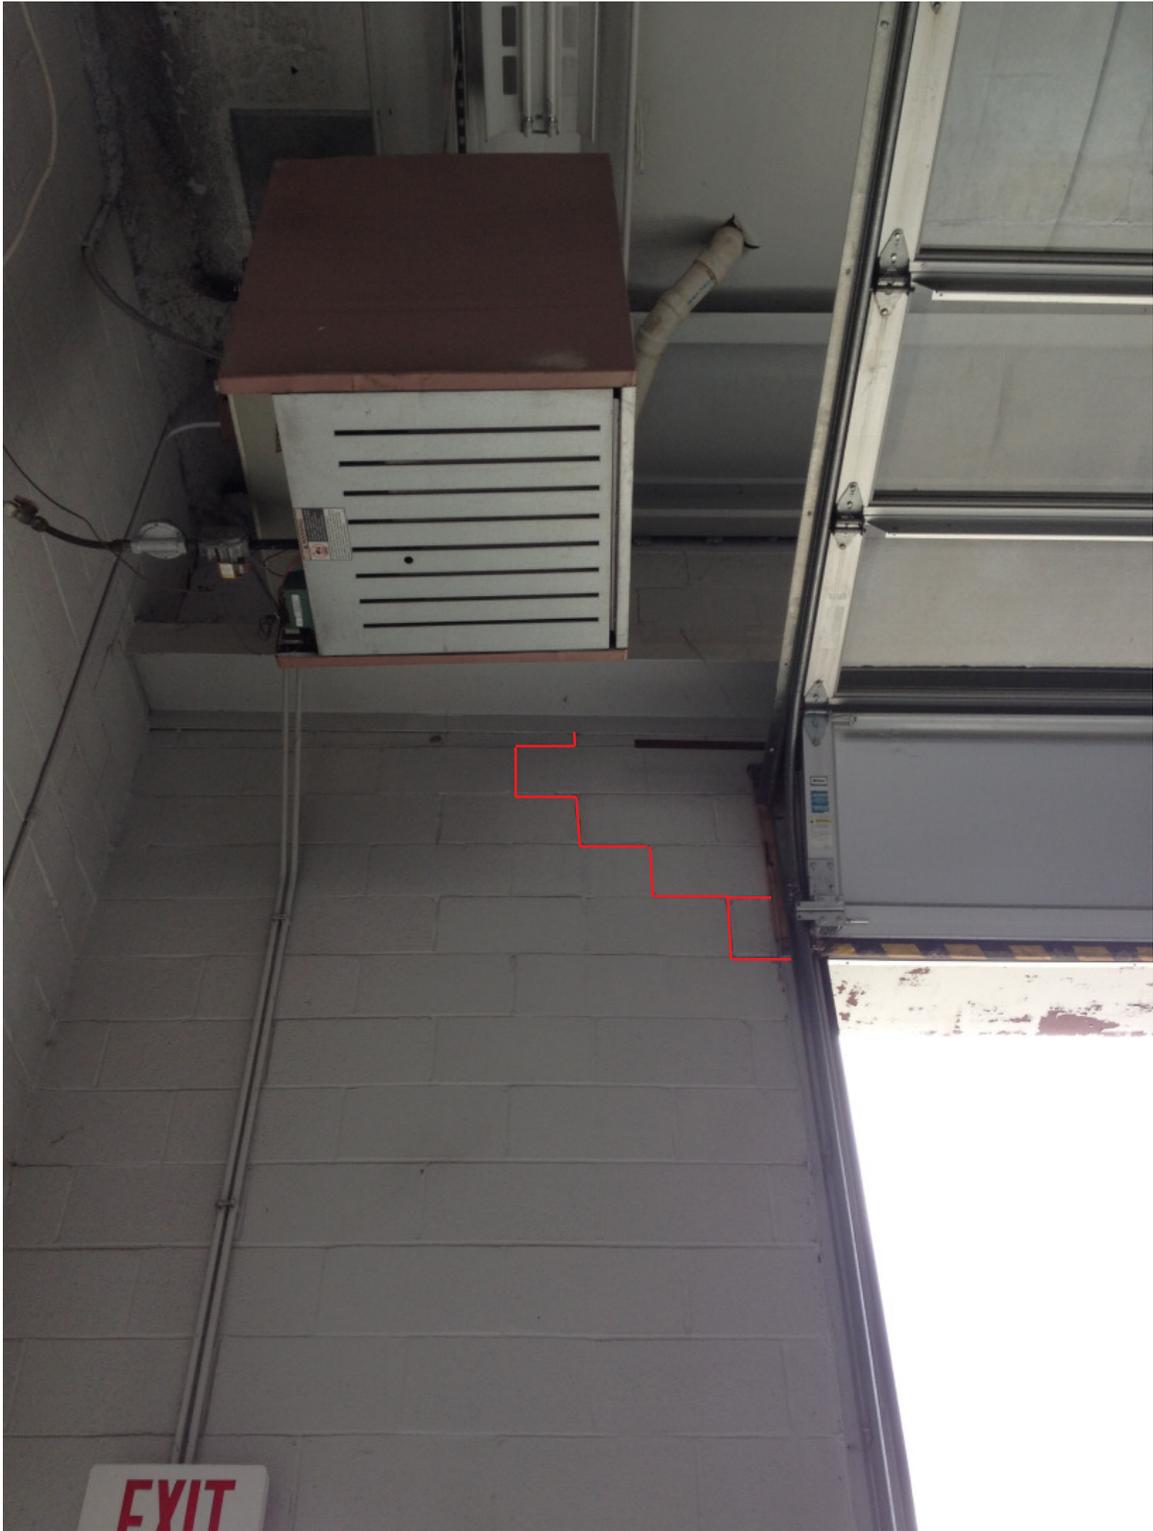
Photo 44: Interior photograph on Northeast quadrant of truck bay. The red line highlights the existing crack in the mortar joint of the exterior concrete masonry unit wall (east side). This crack also is visible in the brick and split face veneer just opposite this picture.

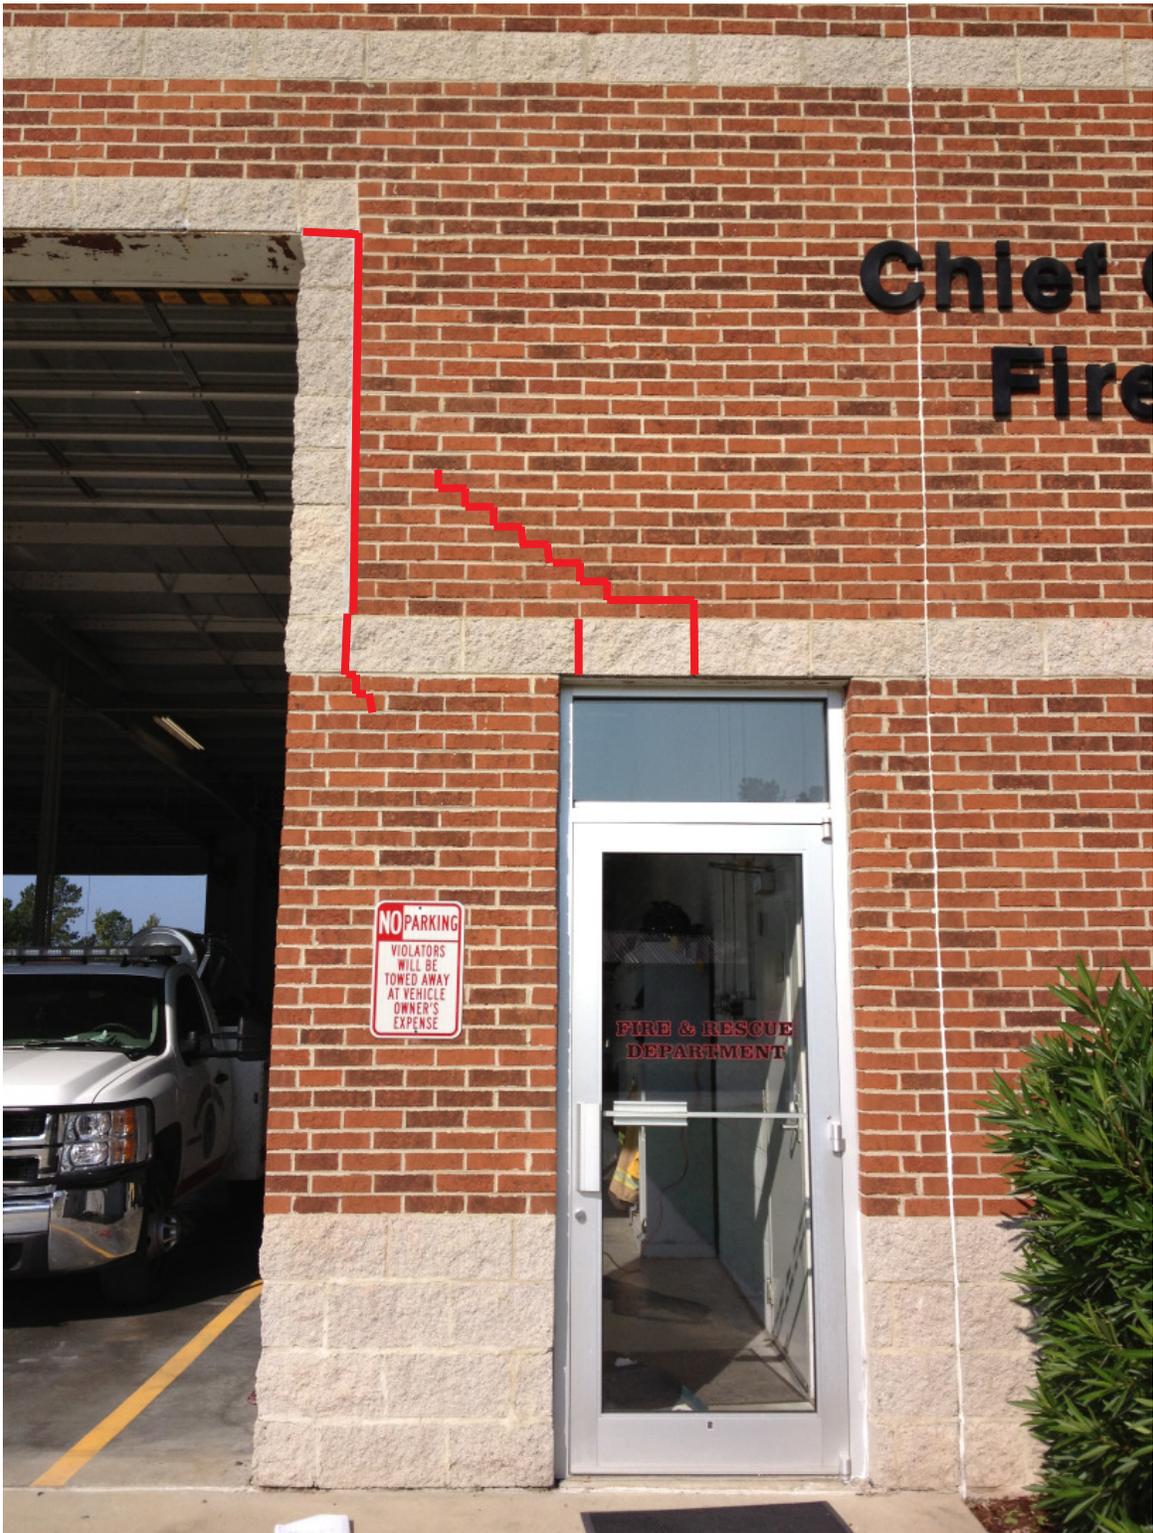
1. *Northeast corner at the front of the truck bay area:* Stepped cracking in the masonry block wall and brick veneer was observed above the right corner of the bay opening and extends downward to the northeast corner above the single door.

Photo 45: Exterior photograph on Northeast quadrant of truck bay. The red line highlights the existing crack in the brick and split face veneer.

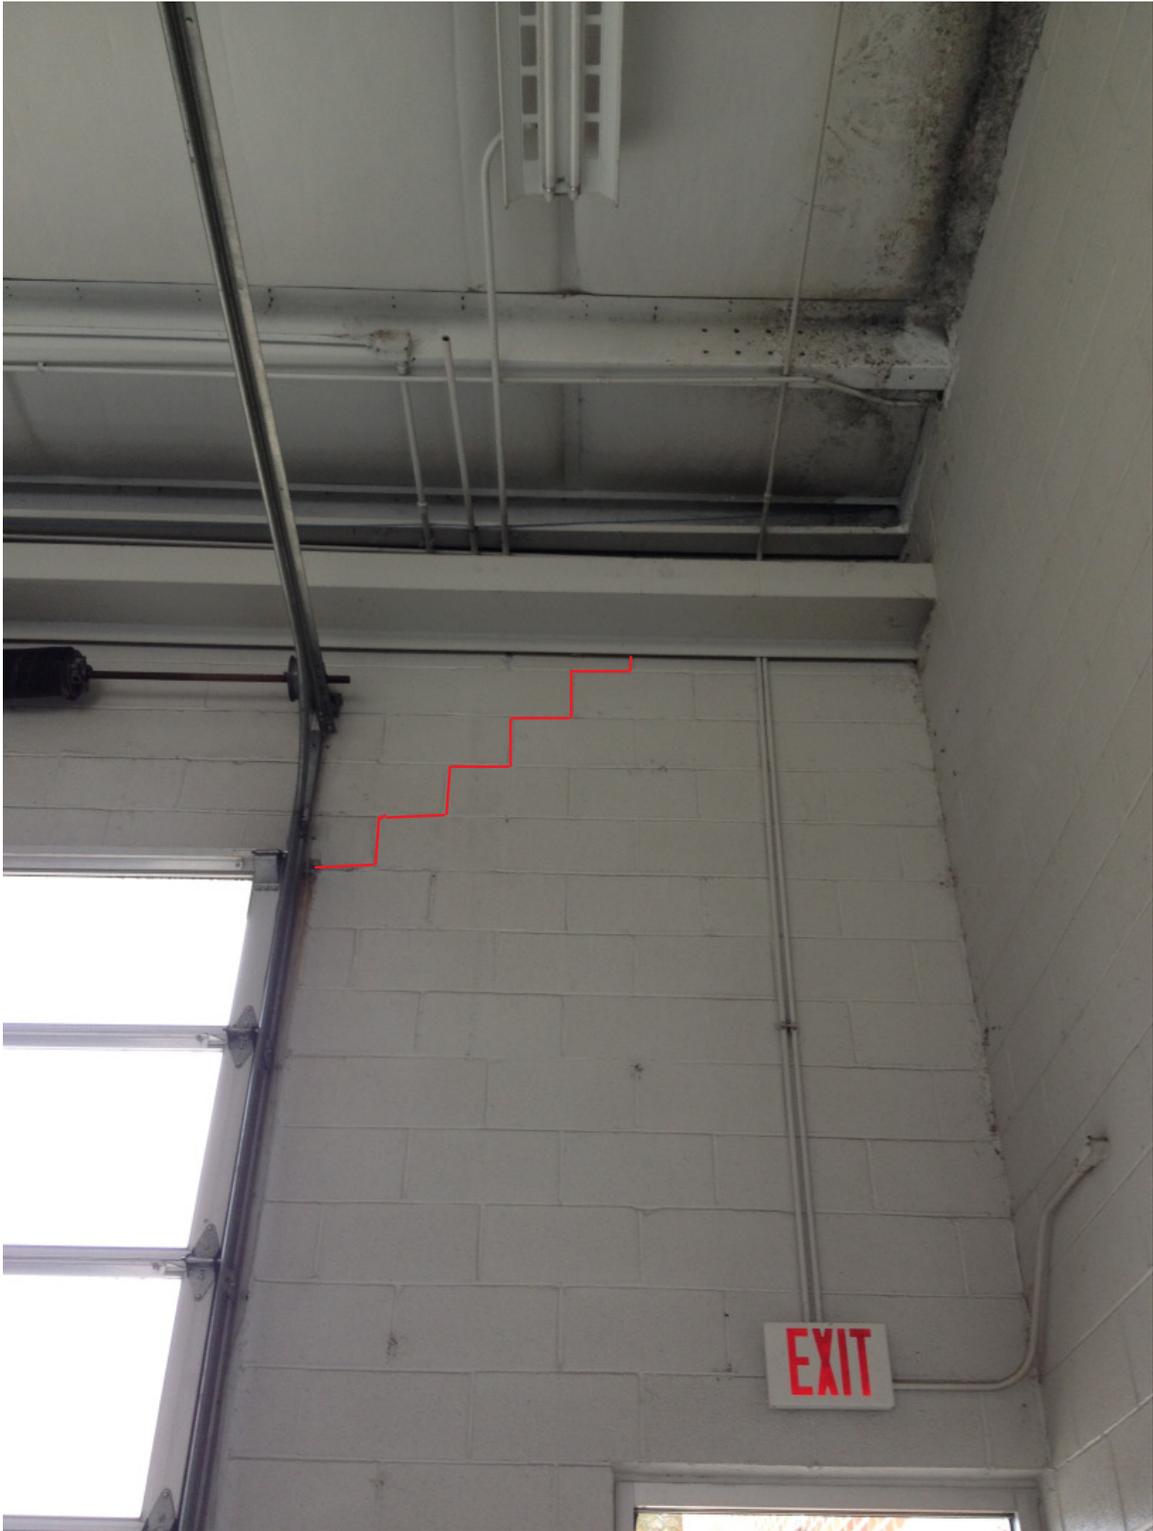
Photo 46: Interior photograph on Northwest quadrant of truck bay. The red line highlights the existing crack in the mortar joint of the exterior concrete masonry unit wall (west side).

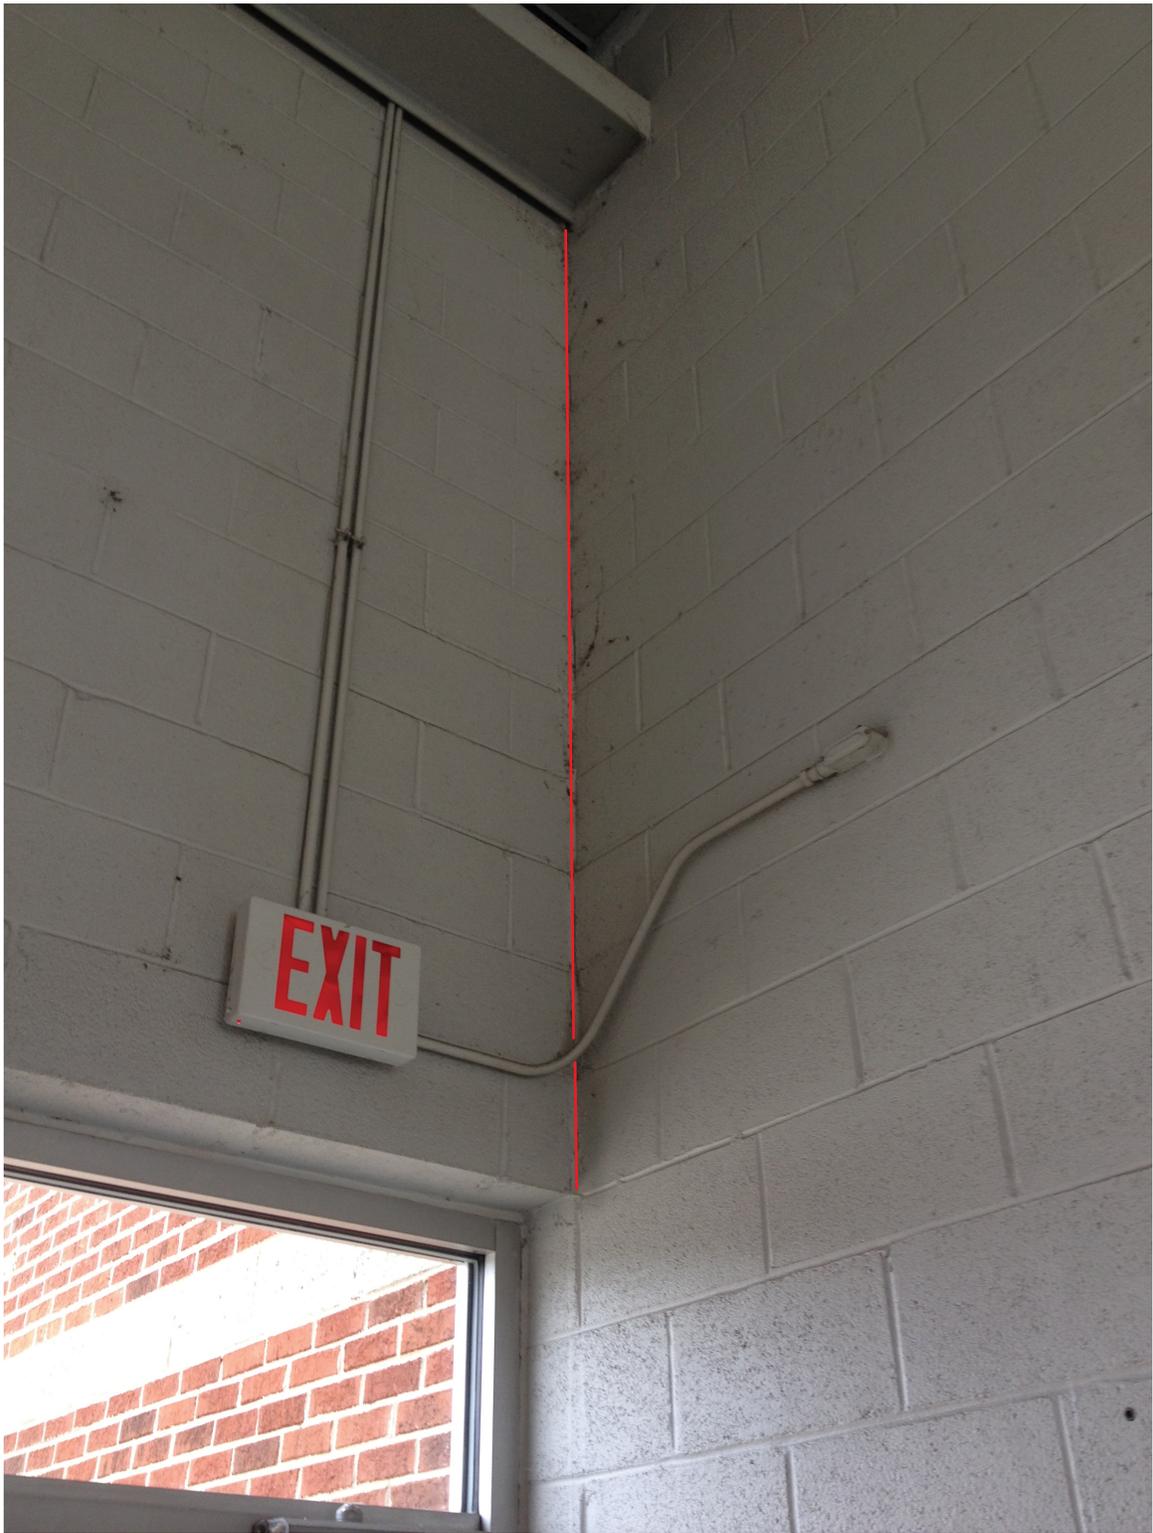
Photo 47: Interior photograph on Northwest quadrant of truck bay. The red line highlights the existing crack at the intersection of the west and north walls of the truck bay.

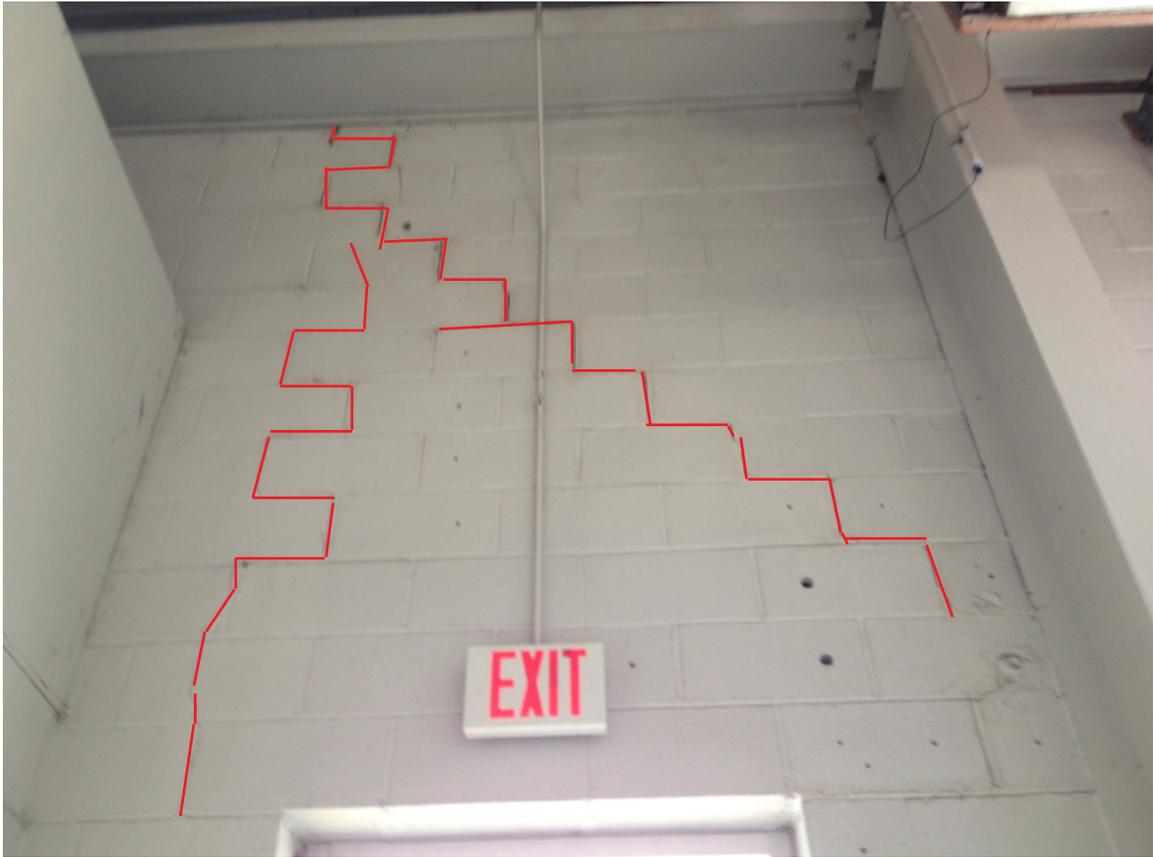
Photo 48: Interior photograph on Southwest quadrant of truck bay. The red line highlights the existing crack in the interior concrete masonry wall (west side).

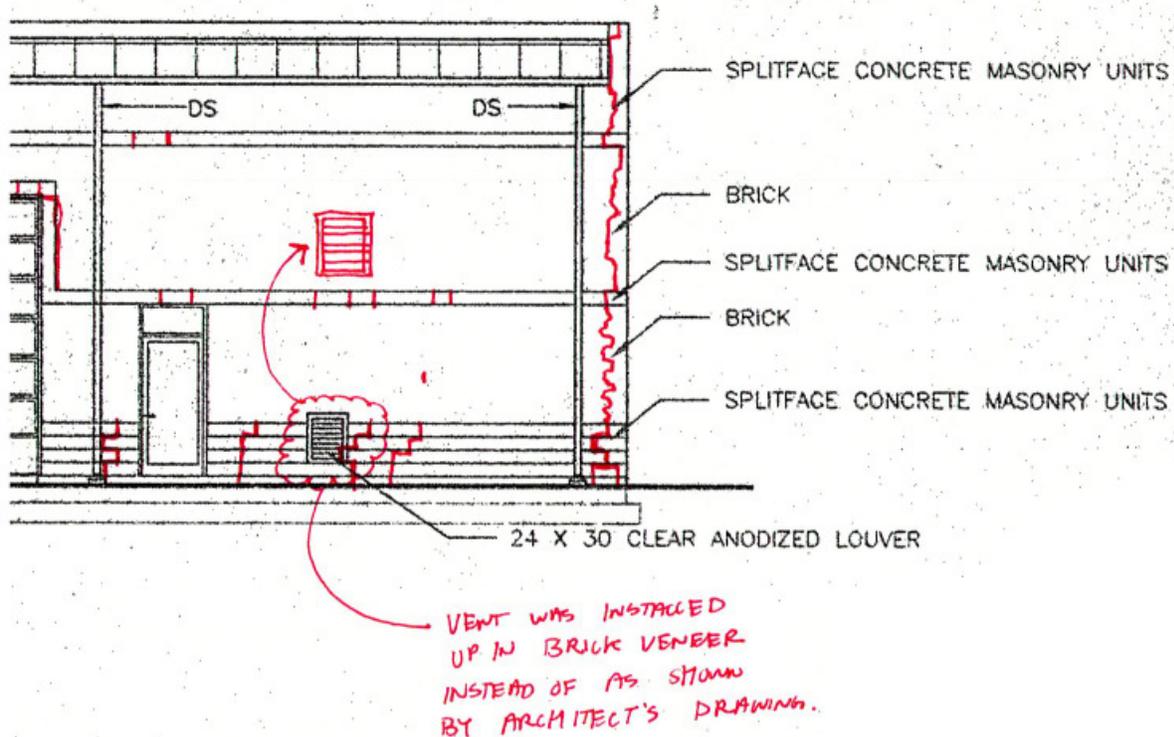
Photo 49: This drawing illustrates the locations of exterior cracks in the masonry veneer at the southwest corner of the building. Many of these cracks are consistent with other non-structural veneer cracks that will be covered in another section later in this report. However, due to the extensiveness of some of the cracks in this area (both interior and exterior), it is believed that most of the cracks in the veneer in this area are the result of horizontal movement of the structural curtain wall. The vertical crack, as seen in the illustration above at the right most corner of the building, is a stress fracture at the point where the west wall meets the more rigid south wall. Due to improper pinning of the curtain wall to the steel structure, this section of wall experiences horizontal movement which causes these stresses in the curtain wall.

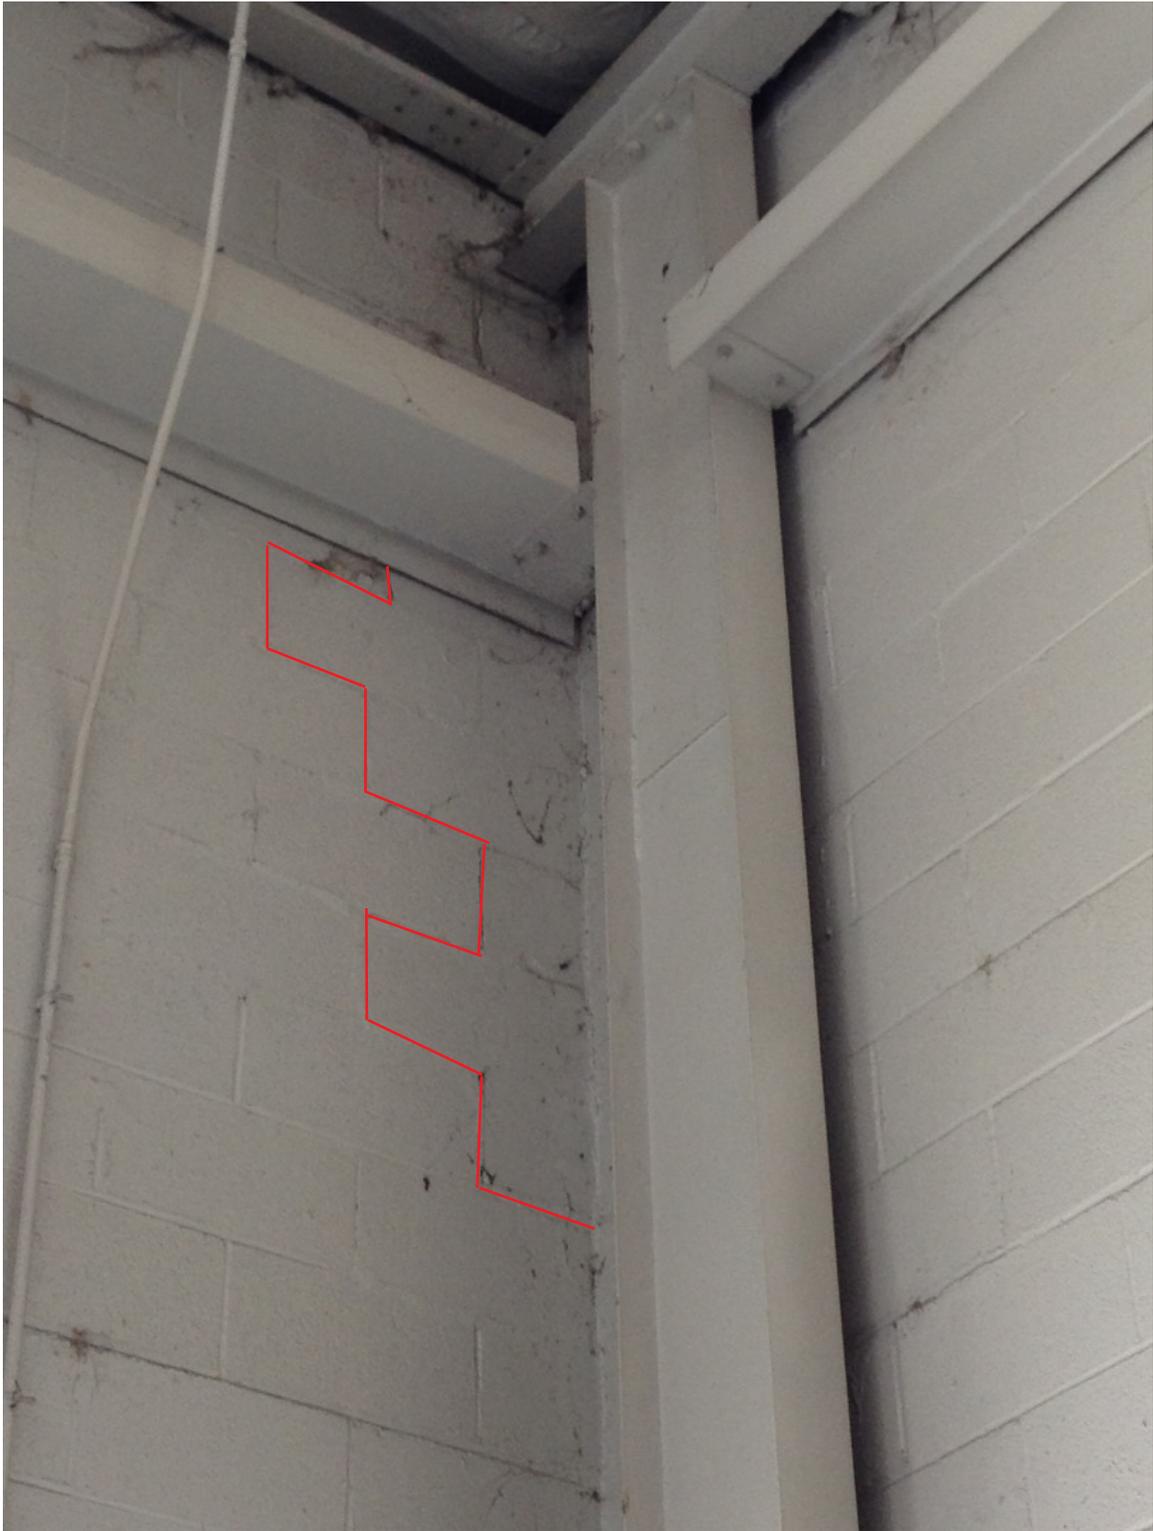
Photo 50: Interior photograph on Southeast quadrant of truck bay. The red line highlights the existing crack at the intersection of the east and south walls of the truck bay.

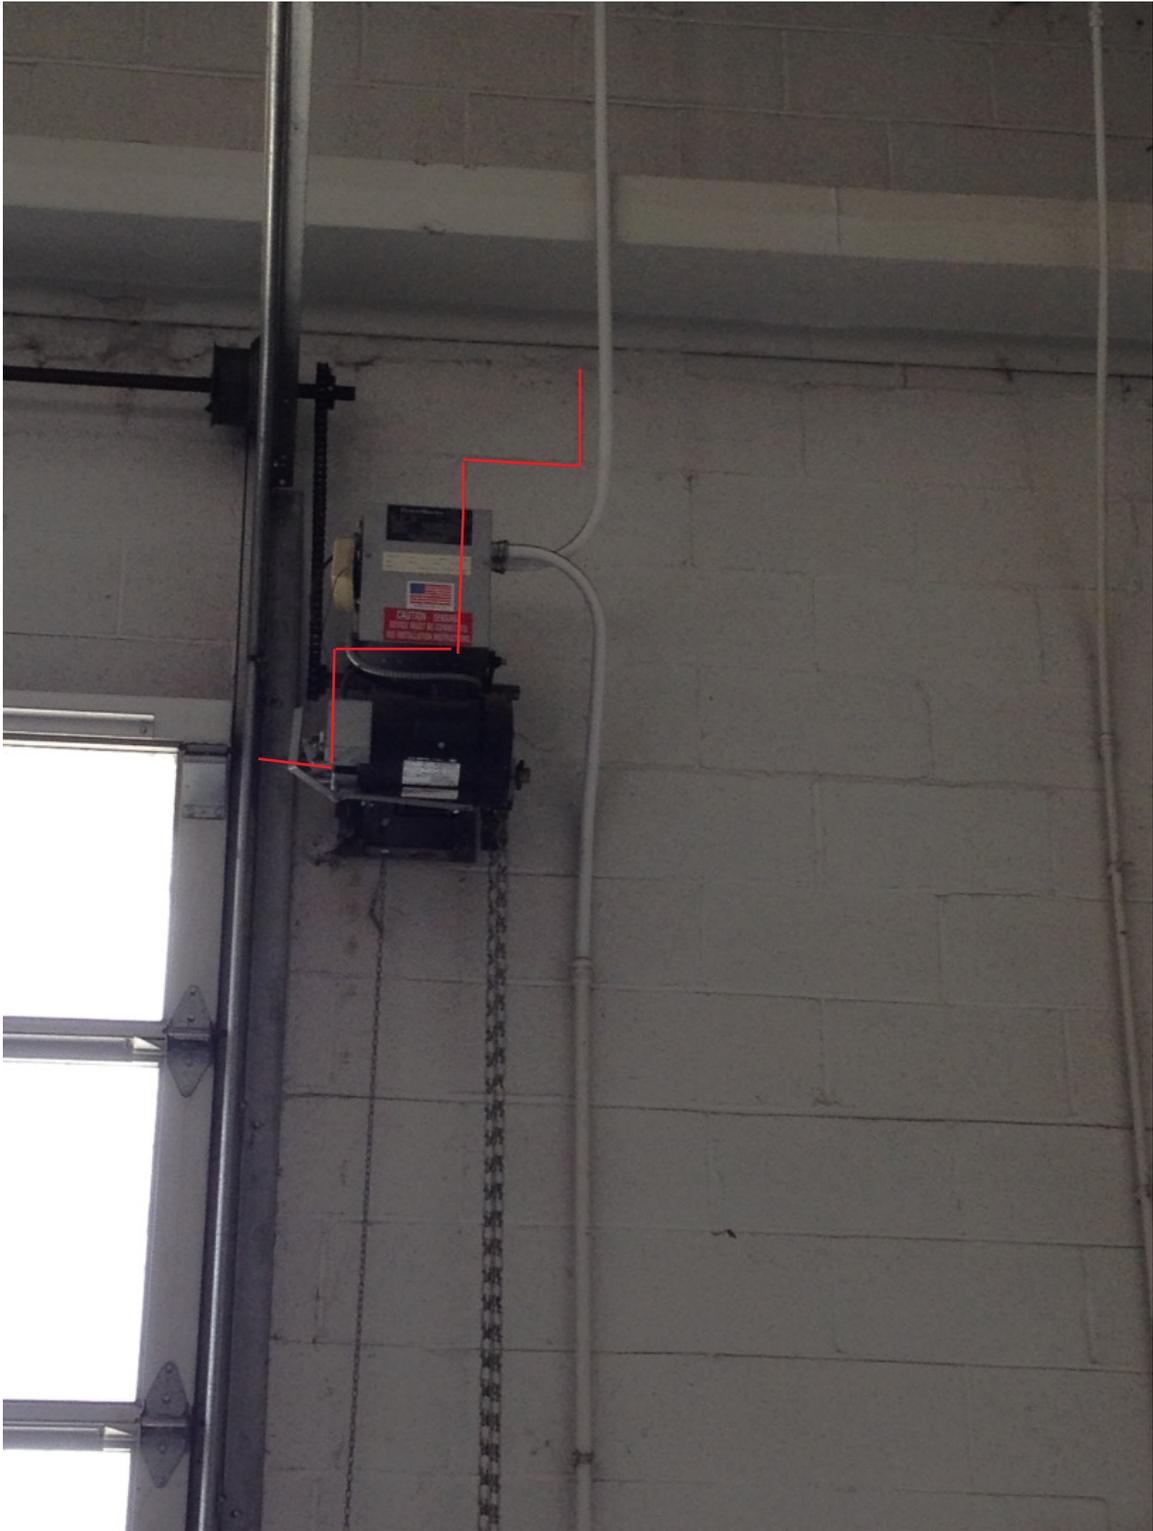
Photo 51: Interior photograph on Southeast quadrant of truck bay. The red line highlights the existing crack at the interior concrete masonry unit wall (east wall).

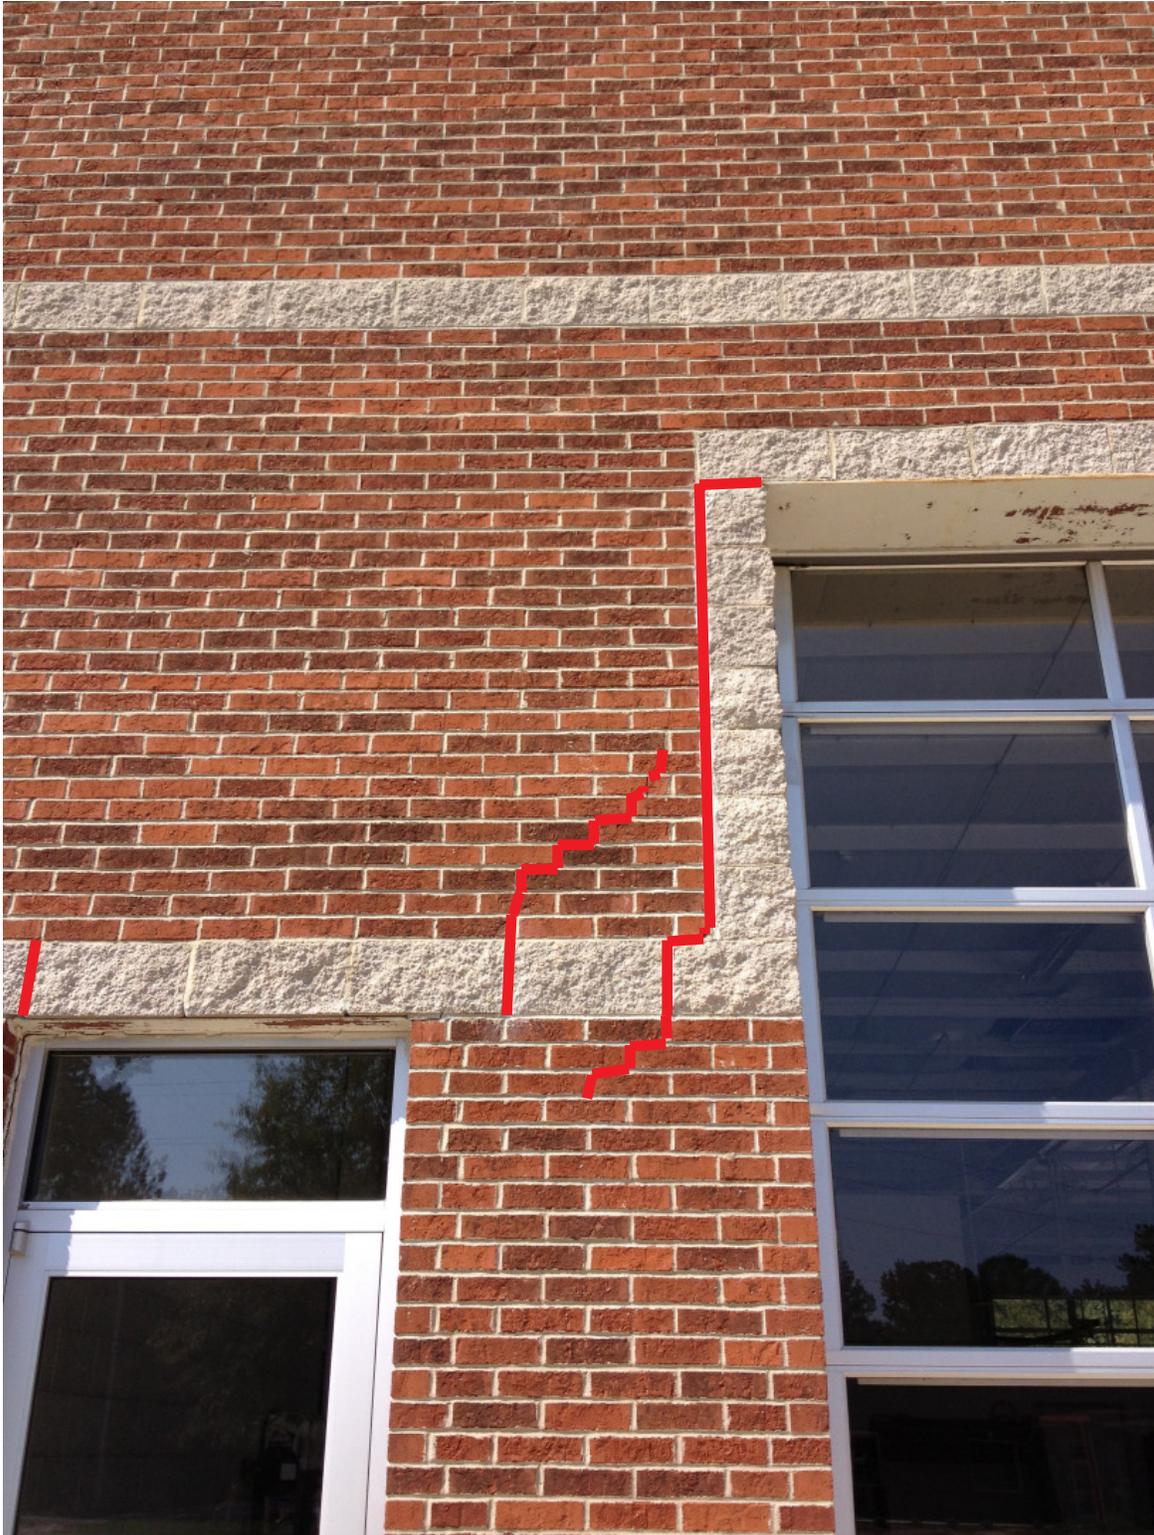
Photo 52: Cracks in the brick and split face at the pedestrian door on the front of the building. These cracks are likely caused by movement of the building veneer, and not due to differential settlement.

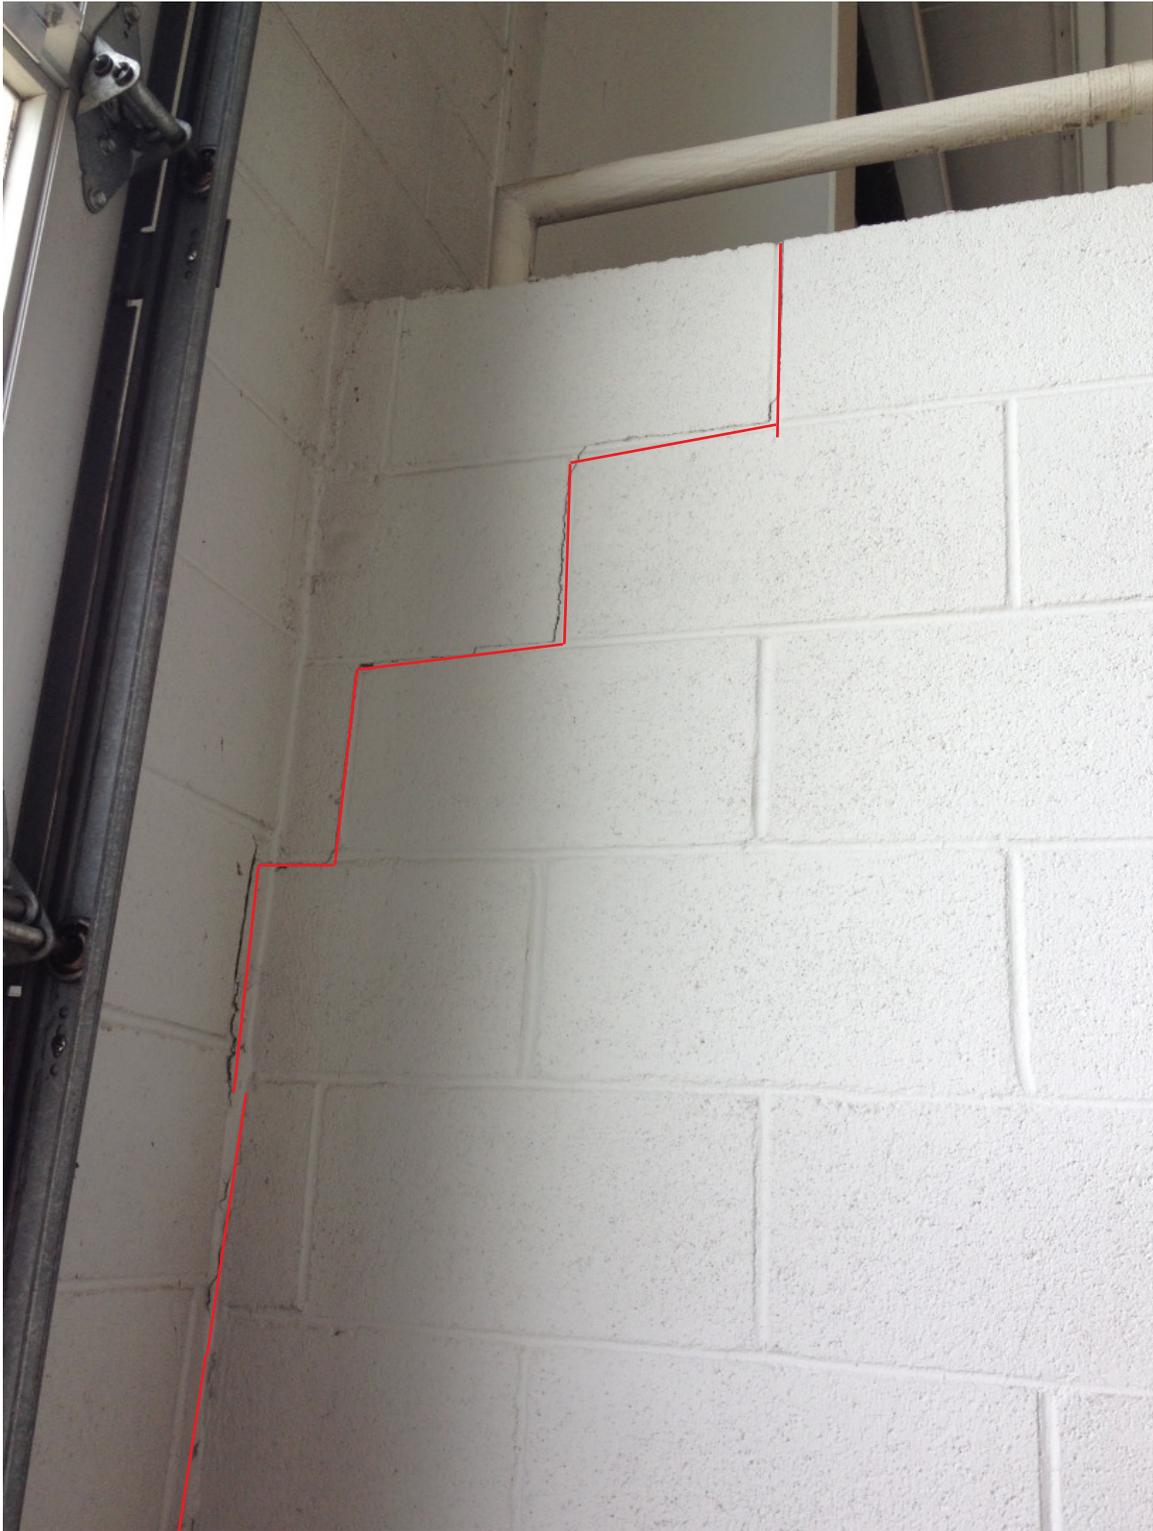
Photo 53: Interior photograph on Southeast quadrant of truck bay. The red line highlights the existing crack at the interior concrete masonry unit wall that separates the service bay from truck bay.

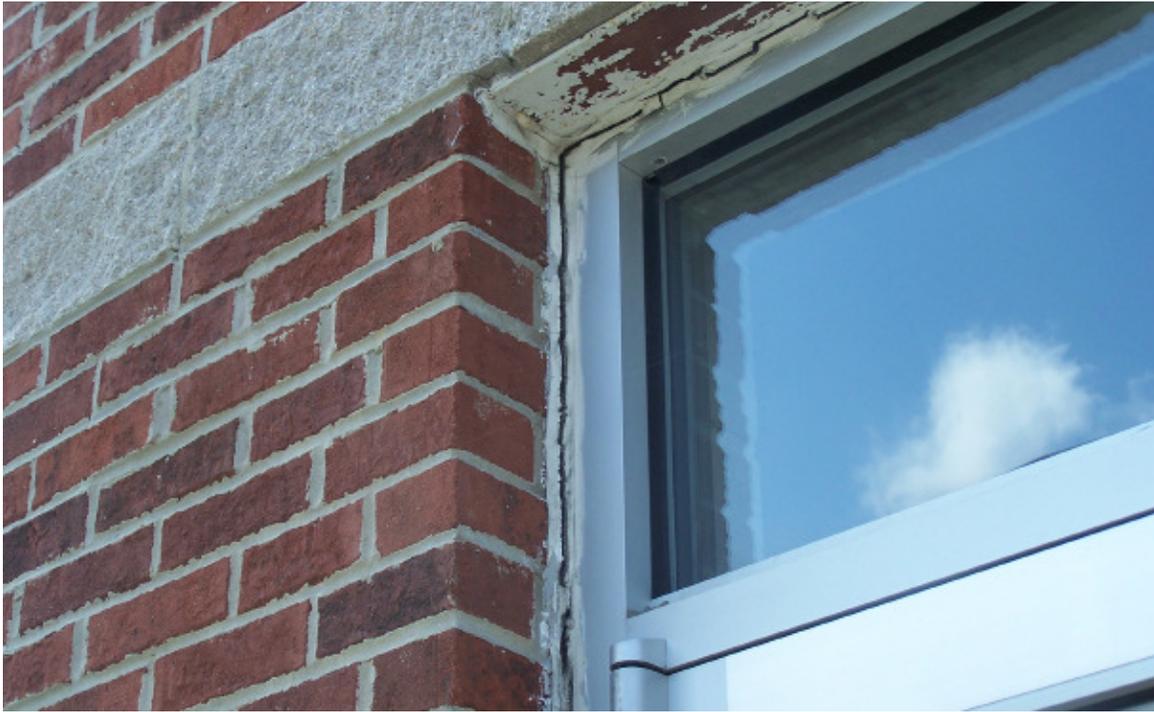
Photo 54: Separation of the door frame and the building veneer at the pedestrian door on the front of the building. This is likely caused by movement of the building veneer, and not due to differential settlement. Also, the caulk has failed in this area and should be cleaned off and reapplied.
