CLARENDON COUNTY FIRE STATION

ASSESSMENT REPORT: EXAMINATION OF EXTERIOR CURTAIN WALL AND ROOF SYSTEMS

PREPARED BY: JEREMY TATE, FILLMORE WILSON, & MIKE HANCE

January 22, 2013

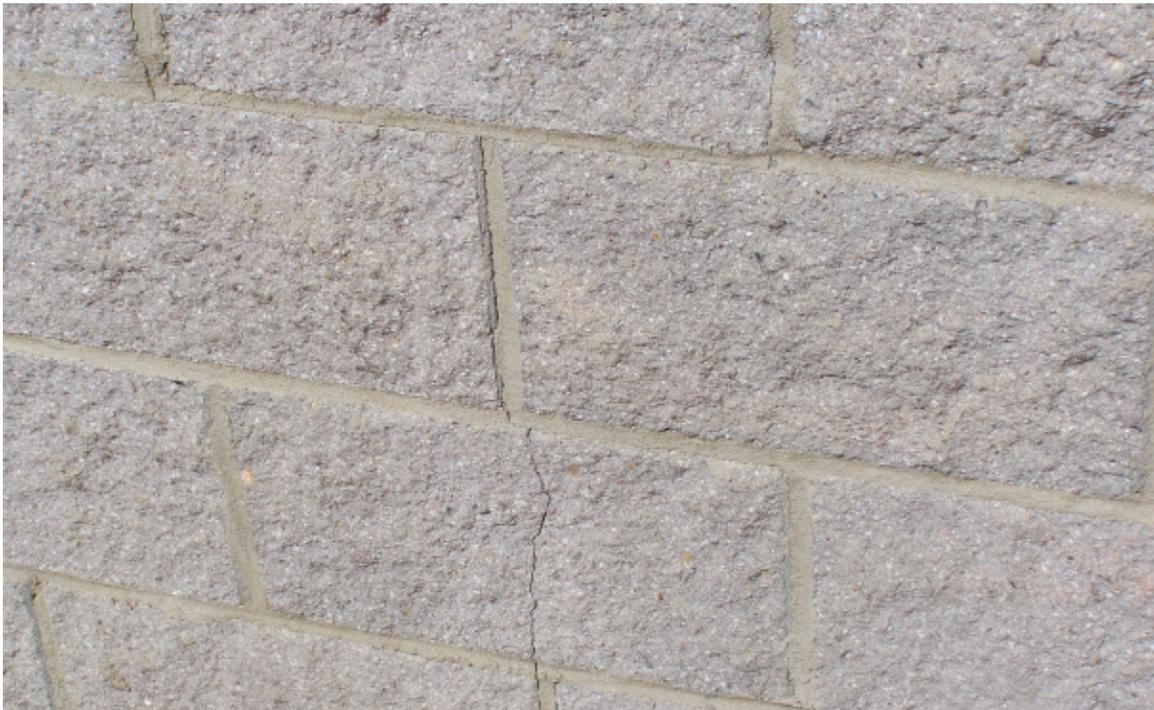
Photos 55: Cracks in the split face veneer on base of the building. These cracks are likely caused by movement in the building veneer and are not structural.

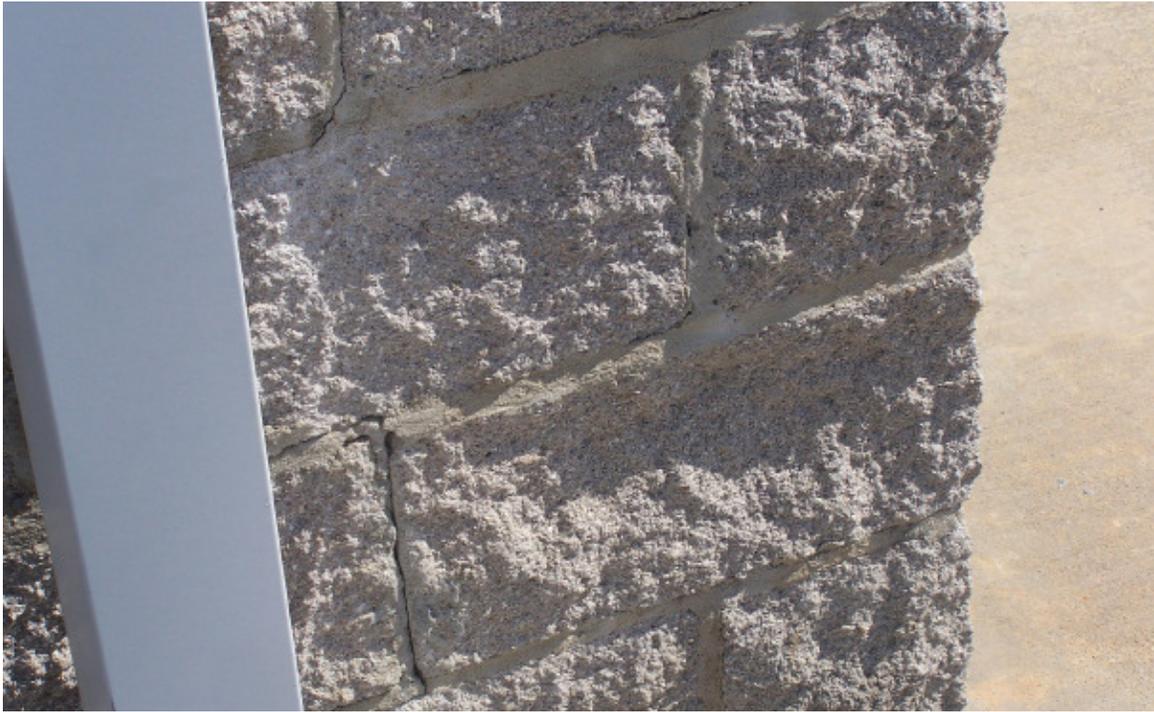
Photos 56: Cracks in the split face veneer on base of the building. These cracks are likely caused by movement in the building veneer and are not structural.

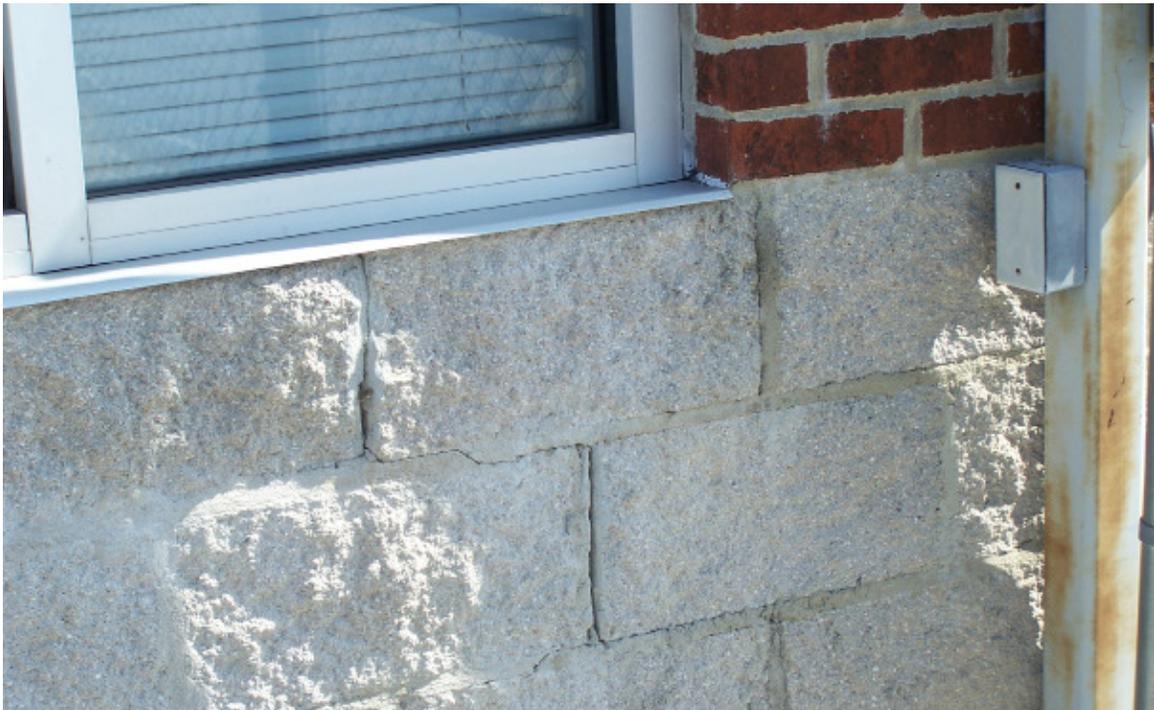
Photos 57: Cracks in the split face veneer under the windows in the building. These cracks are likely caused by movement in the building veneer and are not structural.

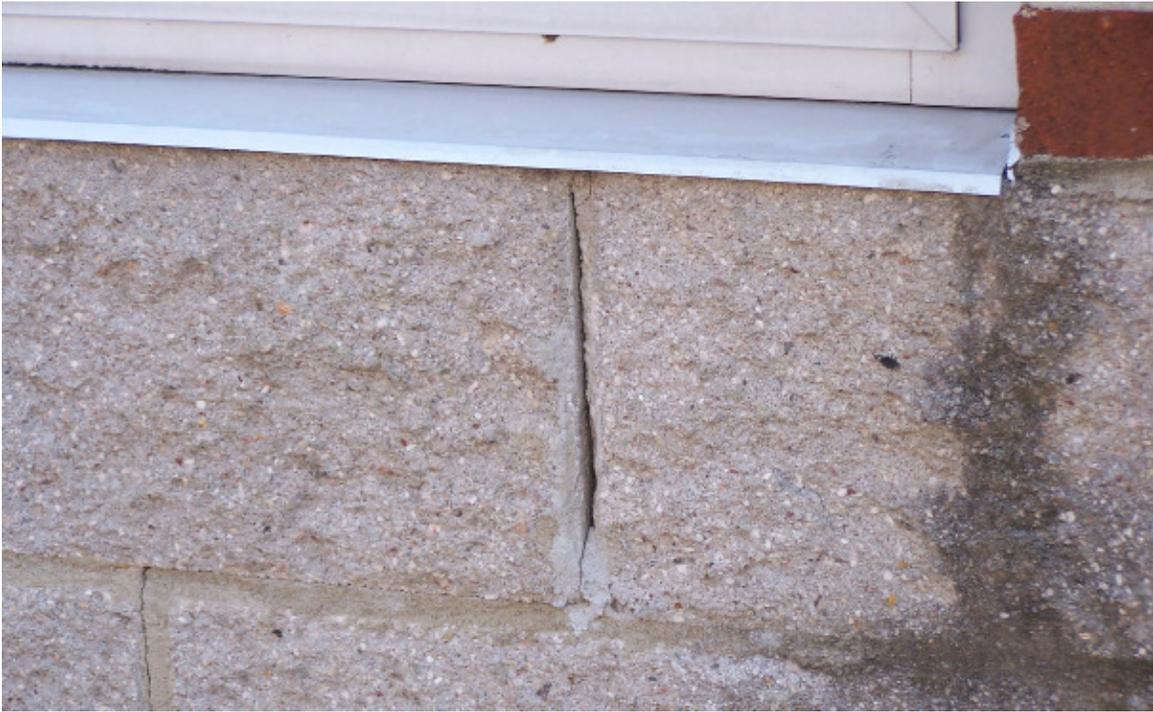
Photos 58: Cracks in the split face veneer under the windows in the building. These cracks are likely caused by movement in the building veneer and are not structural.

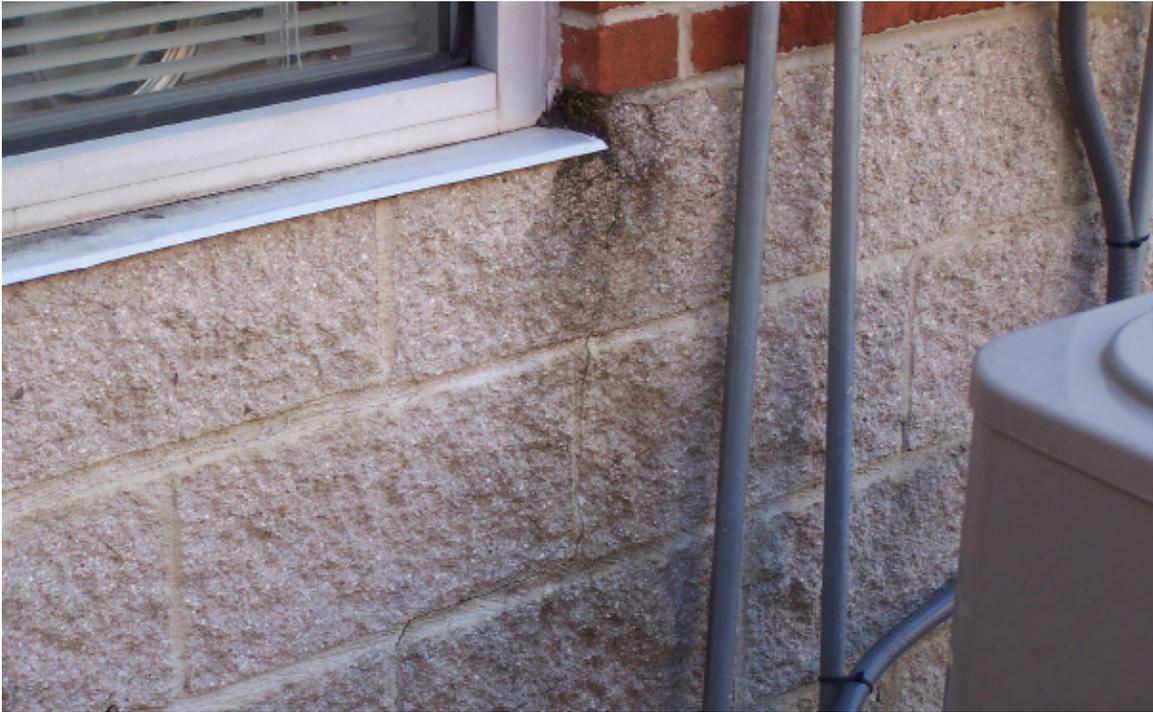
Photos 59: Cracks in the split face veneer under the windows in the building. These cracks are likely caused by movement in the building veneer and are not structural.

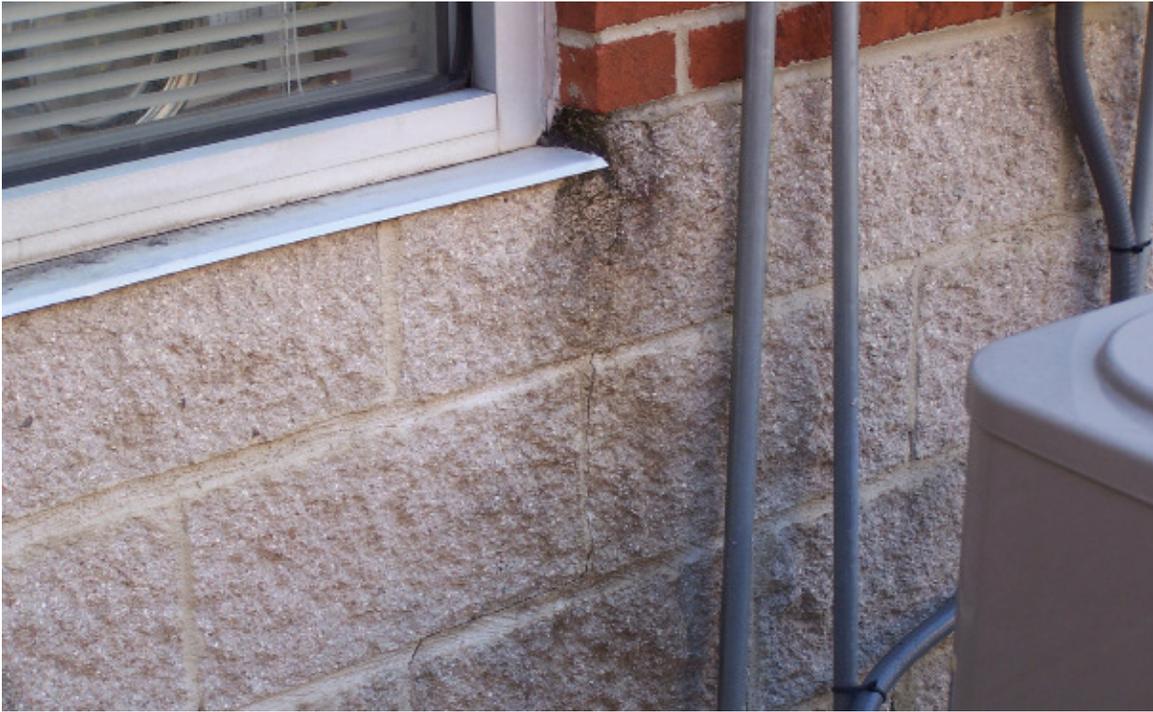
Photos 60: Cracks in the split face veneer under the windows in the building. These cracks are likely caused by movement in the building veneer and are not structural.

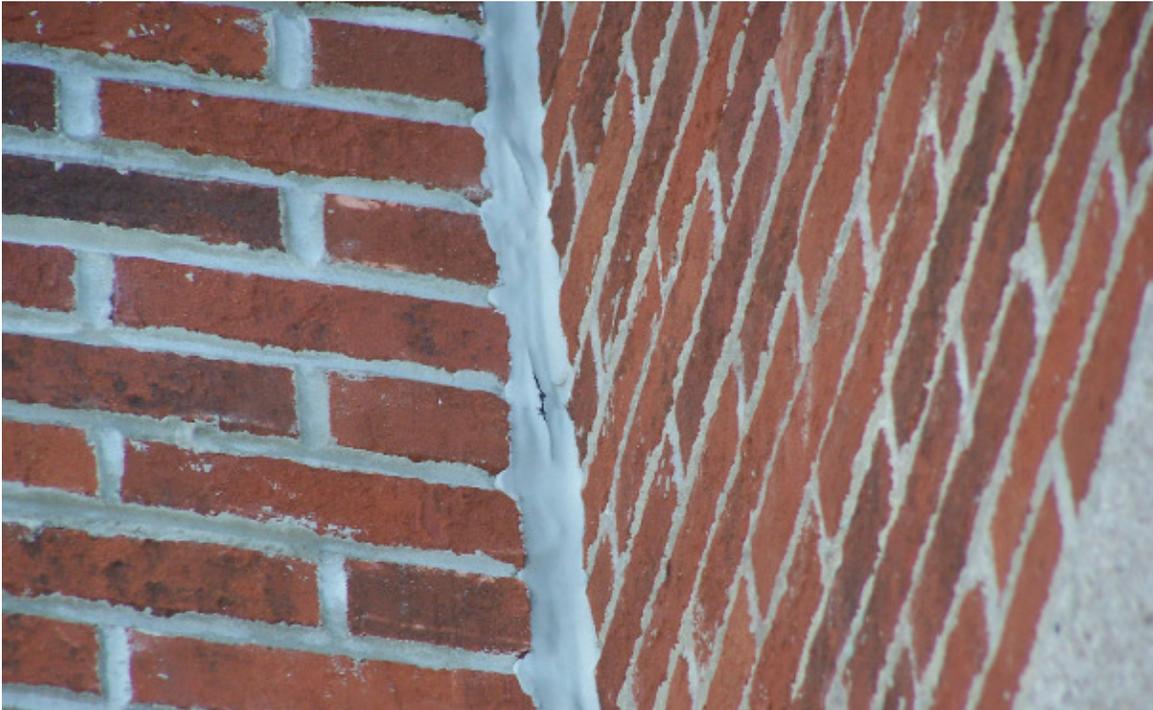
Photo 61: Separation in the caulking at the cold joint between the structures. The movement is not extreme, but should be re-caulked.

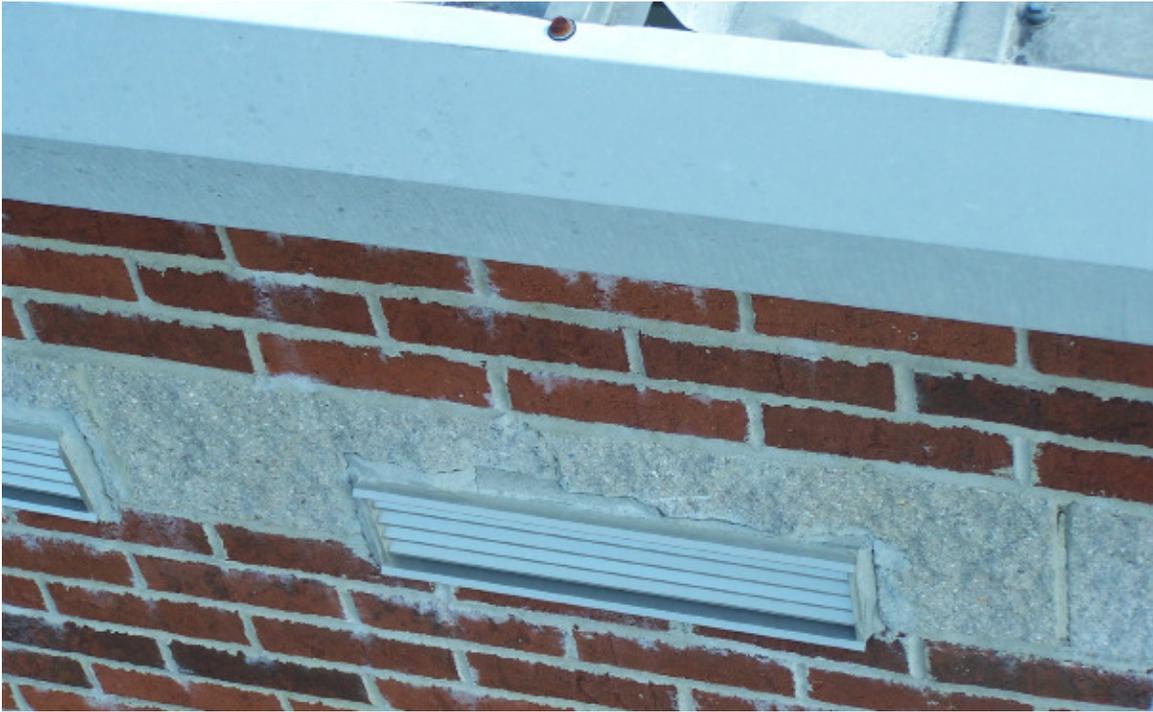
Photos 70 & 71: The mortar on top of the wall vents is cracked and is missing in some places. This allows water to intrude into the structure behind the brick veneer. There is evidence of efflorescence in this area which is the result of moisture behind the brick veneer. The efflorescence is extensive along this entire wall.
