CLARENDON COUNTY FIRE STATION

ASSESSMENT REPORT: EXAMINATION OF EXTERIOR CURTAIN WALL AND ROOF SYSTEMS

PREPARED BY: JEREMY TATE, FILLMORE WILSON, & MIKE HANCE

January 22, 2013

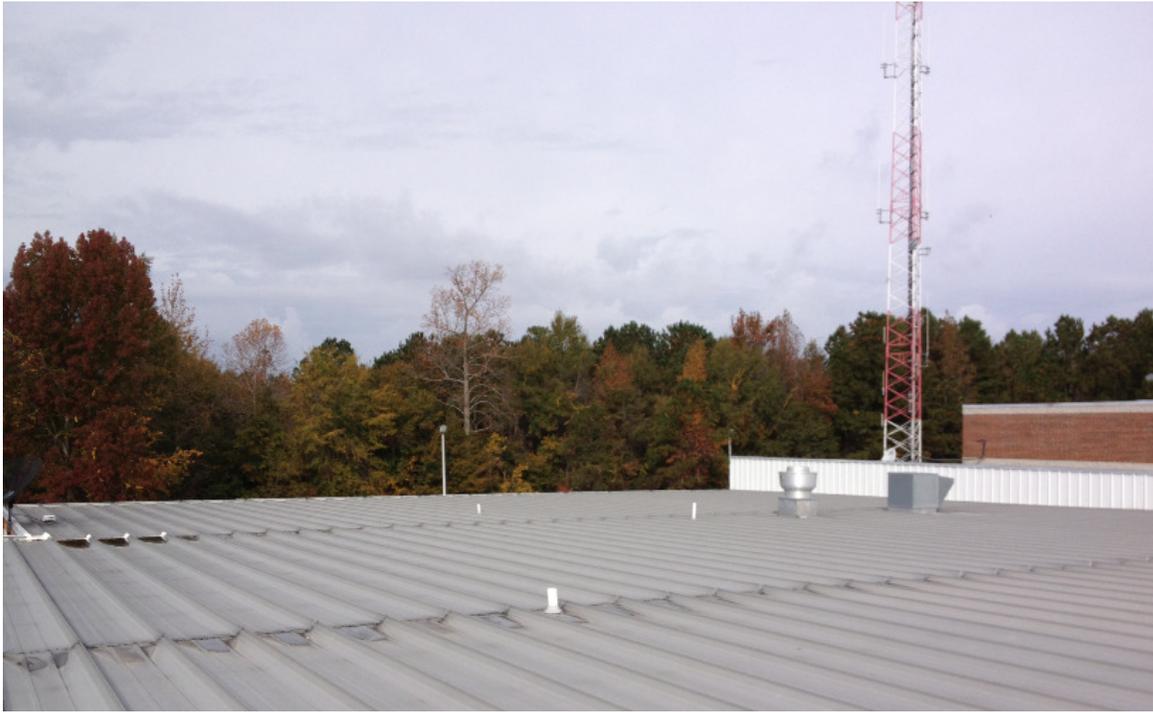
Photo 1: The roof of the fire station is a structural standing seam metal roof. The roof panels are set on premanufactured roof purlins spaced 5'-0" on center and the slope of the roof is 1/4" per 1'-0". The ends of standing seam metal panels are positive lapped with a lockbar securing the panels together.

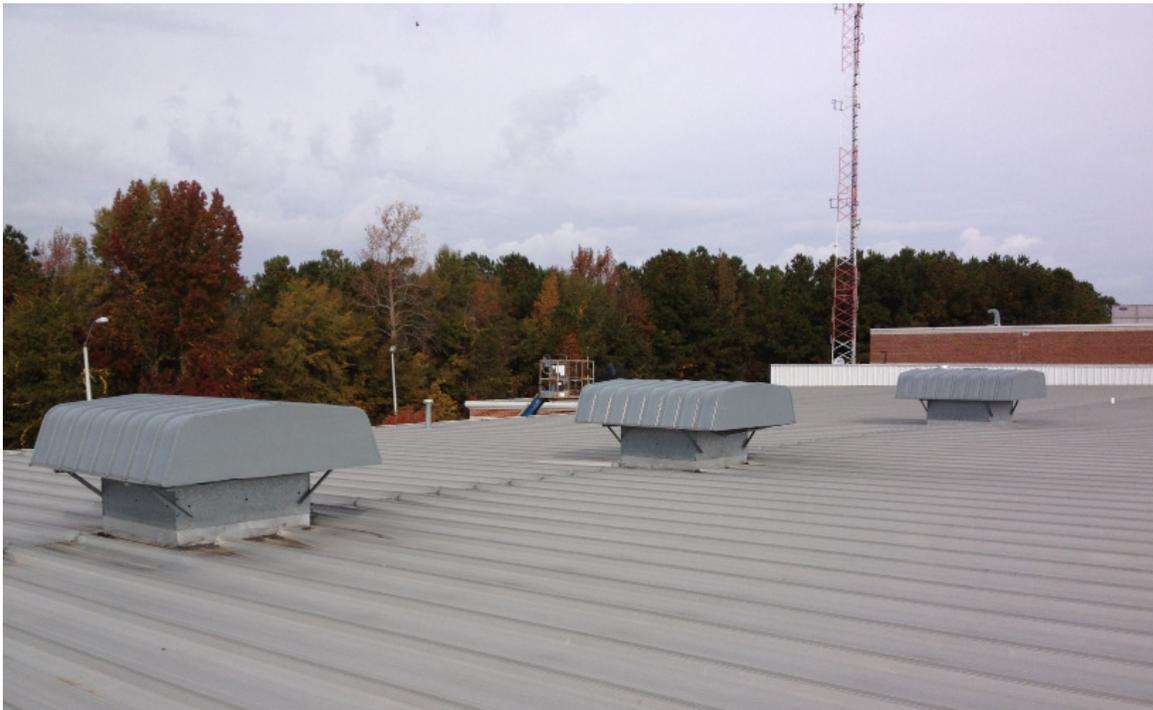
Photo 2: The roof of the fire station is a structural standing seam metal roof. The roof panels are set on premanufactured roof purlins spaced 5'-0" on center and the slope of the roof is 1/4" per 1'-0". The ends of standing seam metal panels are positive lapped with a lockbar securing the panels together. This photograph shows three large exhaust fan penetrations within the metal roof.

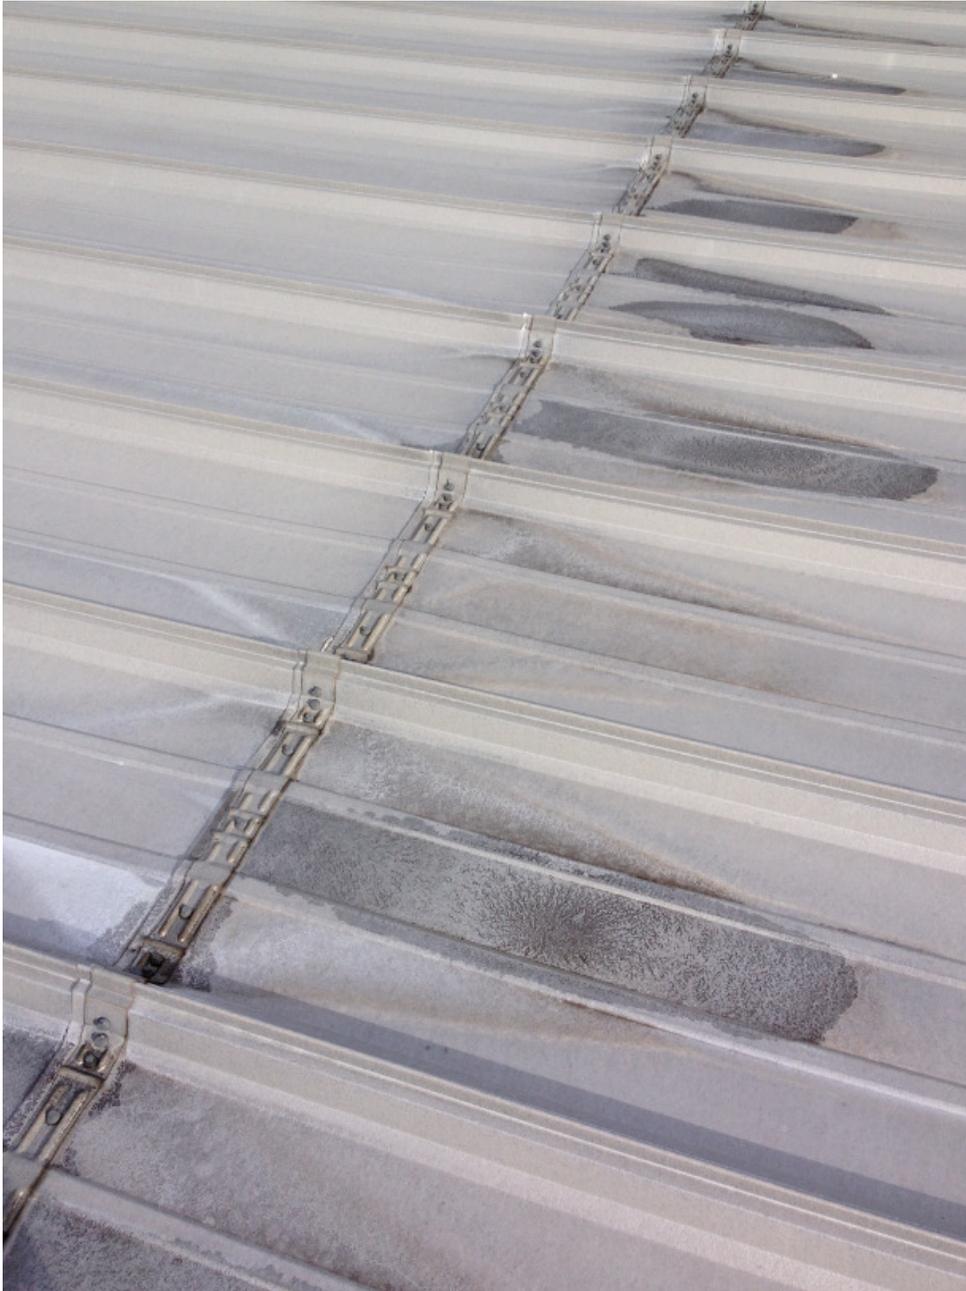
Visual inspection reveals that the SSSMR panels have deflected and are holding water on the eastern side of the end lap lockbars and the eastern side of all rooftop penetrations such as plumbing vents, gas vents, and HVAC ventilators. There is evidence that water has and continues to enter the building through the various roof fastenings and penetrations. The metal standing seam roof system is not adequately pitched to ensure the proper runoff of the water. The National Roofing Contractors Association (NRCA) recommends that an SSSMR system be installed on roofs equal to or greater than 1/2" per foot. This type of roofing system is not appropriate for a 1/4" per foot roof slope which is the pitch of the existing Fire Department roof. Due to the deflection in the roof panels, the lockbars act as a dam to prevent the discharge of even the smallest amount of water (morning condensation). As the water sits, the fasteners degrade and begin leaking. In many instances, the fasteners were loose and/or missing leaving a void and path for water to enter the building. There are roof patches that were installed at various times to prevent the water intrusion. These patches appear to be an elastomeric coating and should only be considered as temporary repairs.

Photo 3: Closeup view of the positive lap of standing seam panels and the series of lockbars that connect the ends of the panels together. Note the evidence of standing water to the east side of the lockbars. The roof slopes 1/4" per foot from the east to the west. The pan adjacent to the lockbars have deflected creating a dam that prevents all the water from running off the roof.

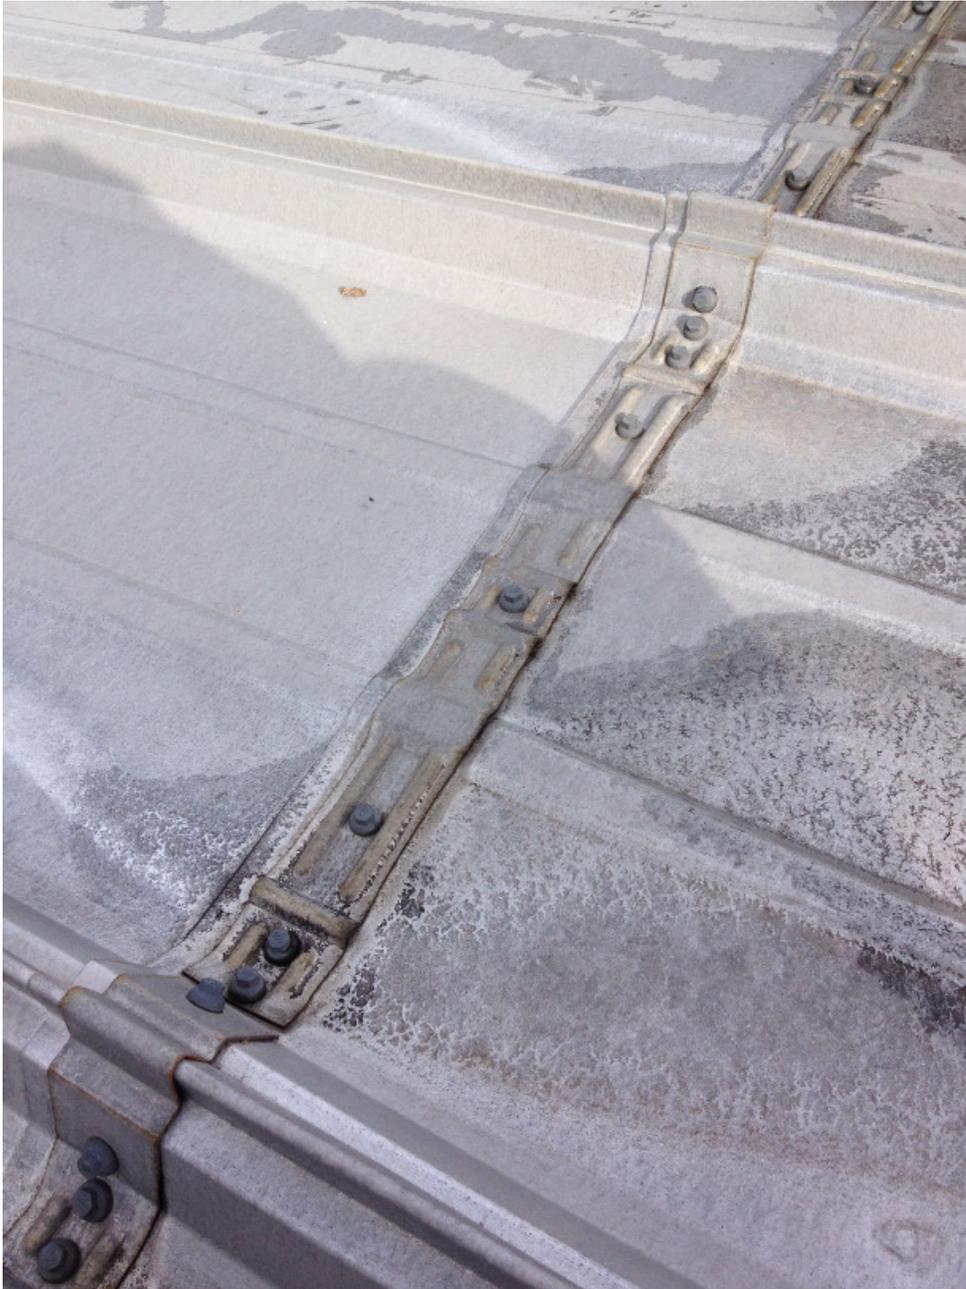
Photo 4: Closeup view of the positive lap of standing seam panels and the series of lockbars that connect the ends of the panels together. Note the evidence of standing water to the east side of the lockbars. The roof slopes 1/4" per foot from the east to the west. The pan adjacent to the lockbars have deflected creating a dam that prevents all the water from running off the roof.

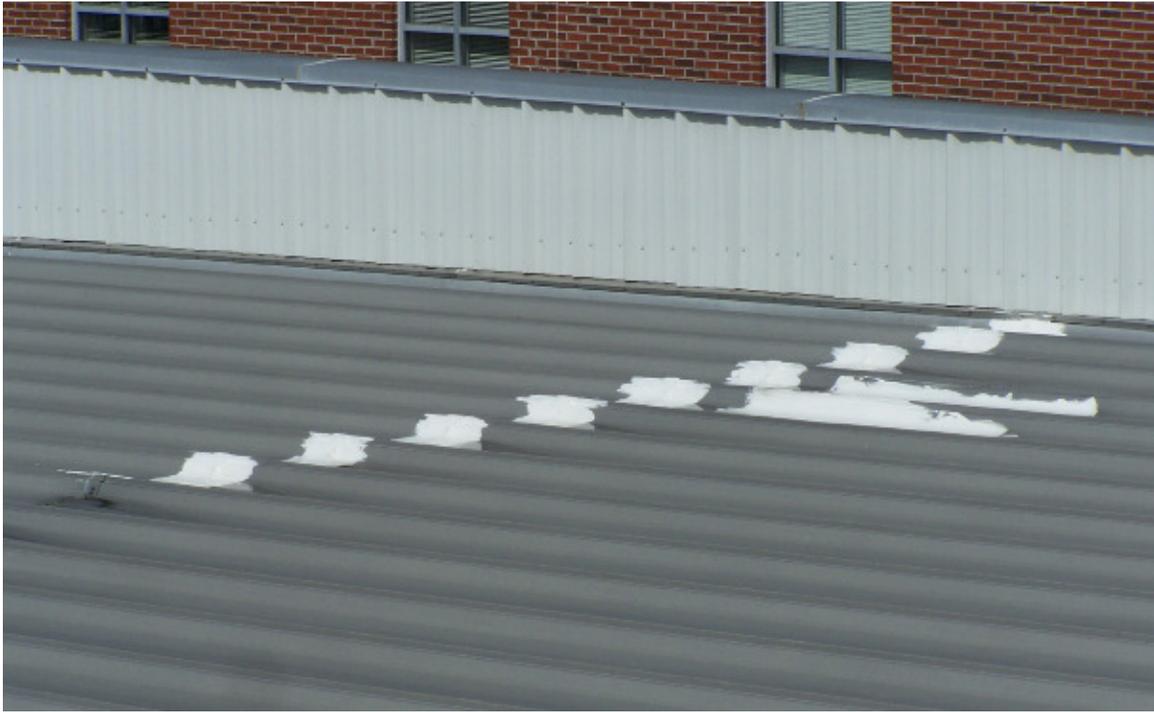
Photo 7: Elastomeric coating on another joint in the metal pan roof. There is evidence of water ponding in this area also.

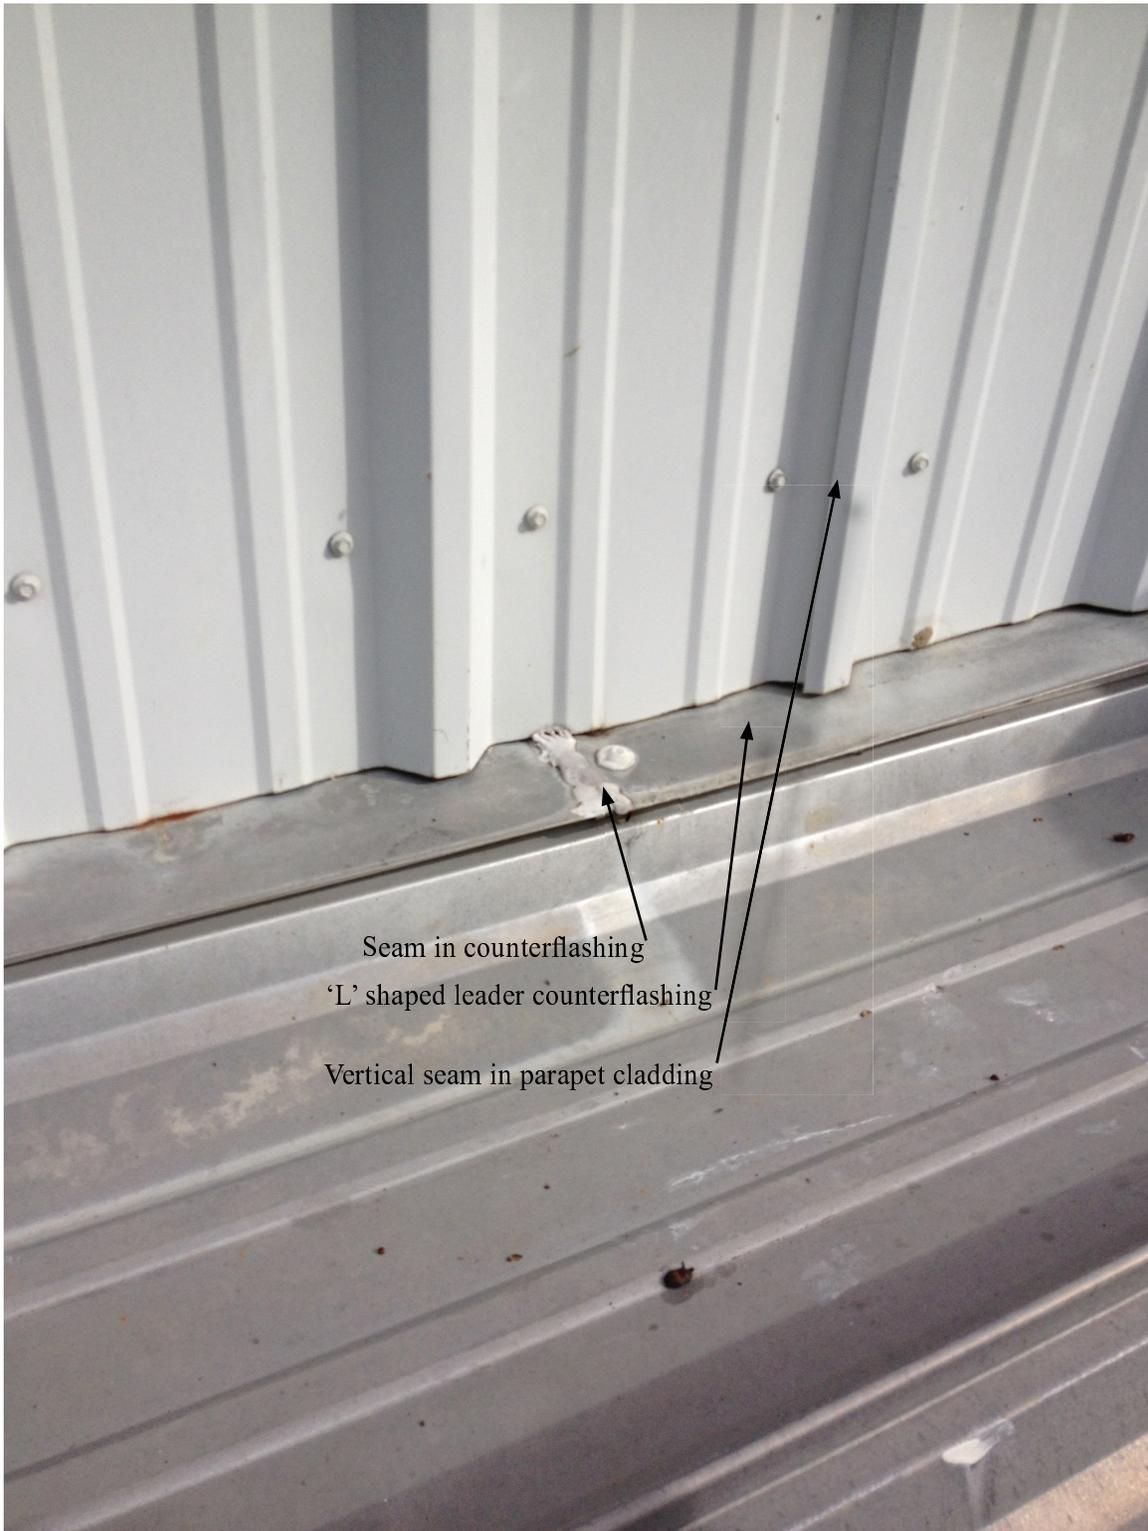
The metal coping along the top of the parapet wall has failed in many instances thus allowing water to infiltrate the wall assembly. The metal wall cladding below the parapet cap and just above the metal standing seam roof panels appears to be in good condition. However, it is believed that many of the face fasteners have degraded and are currently allowing water to infiltrate the wall assembly.

Seam in counterflashing
'L' shaped leader counterflashing
Vertical seam in parapet cladding

Photo 16: Closeup view of the parapet wall cladding and standing seam metal roof panel intersection. The parapet wall cladding panels are face-fastened to the parapet wall framing with sheet metal screws and rubber washers. The vertical metal cladding panels rest on a piece of 'L' shaped leader counterflashing which turns up behind the metal parapet cladding. The 'L' shaped piece of leader counterflashing flashes over the metal standing seam panels. There is evidence that the seams between the vertical metal parapet wall cladding leaks as well as many of the face-fasteners. The 'L' shaped piece of leader counterflashing also leaks at the seams between individual segments of counterflashing.

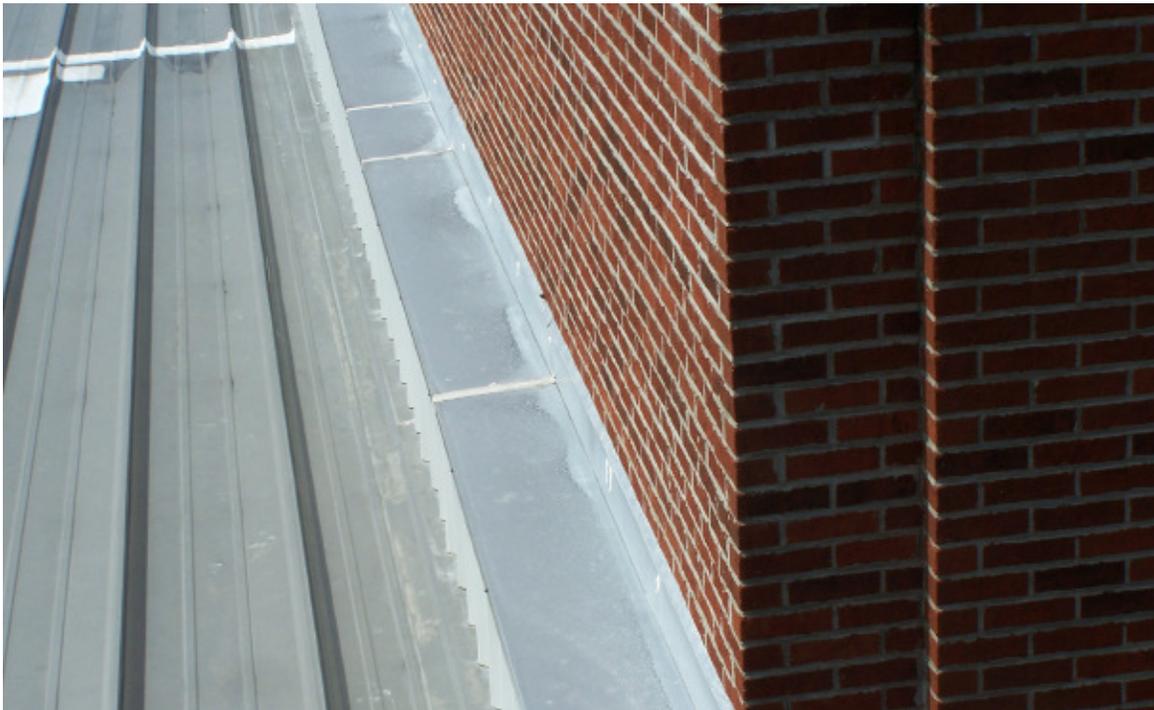
Photo 33: The Parapet on the North side of the building where it abuts the Sheriffs Building. The parapet cap slopes towards the Sheriffs Building and has evidence that water is ponding on the parapet at the intersection of the two structures.

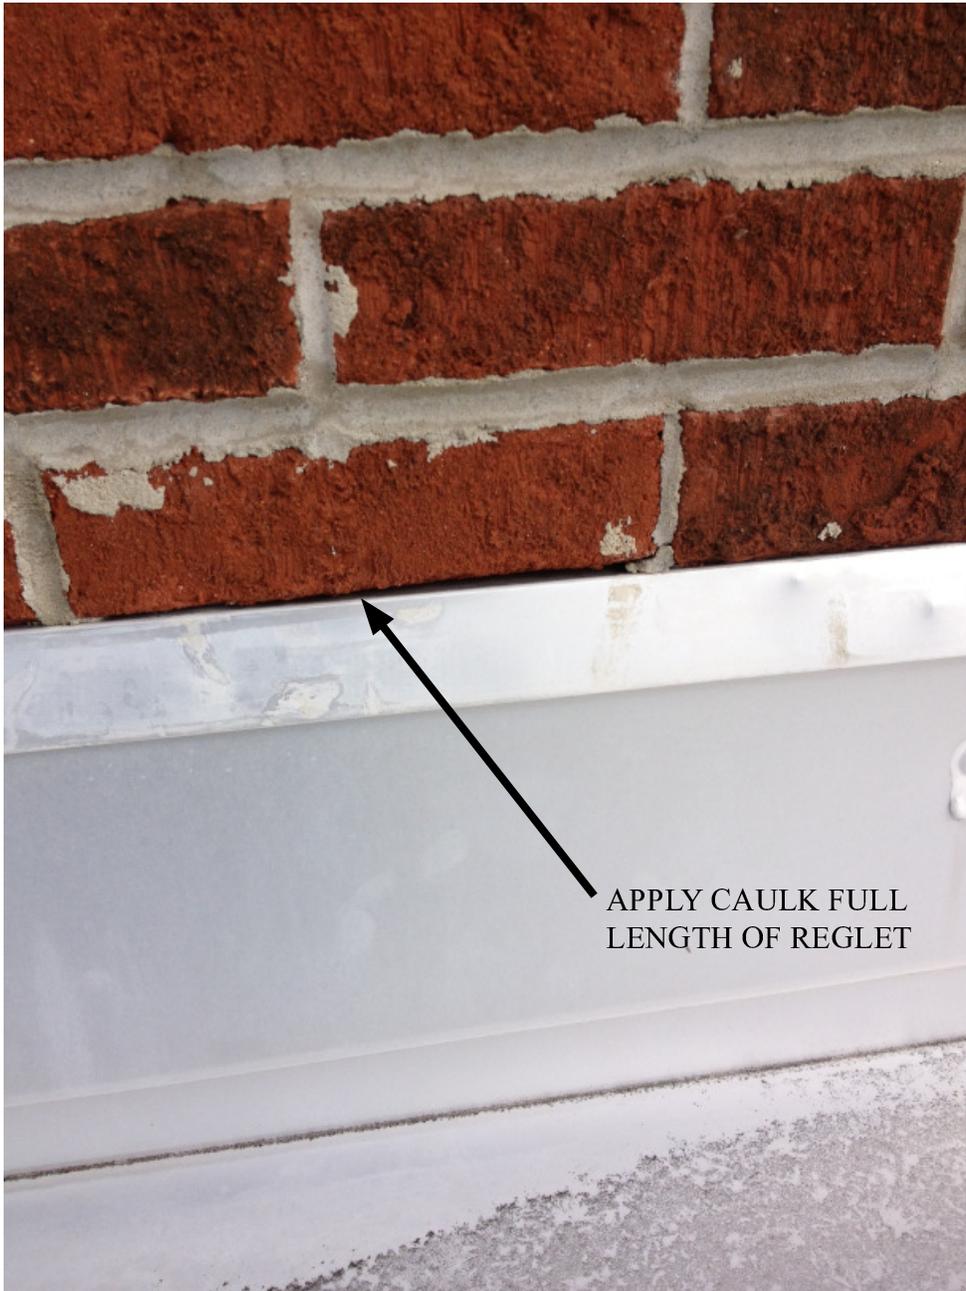
Photo 34: The Parapet on the North side of the building where it abuts the Sheriffs Building. The counterflashing has been inserted into a reglet cut into the mortar. However, the reglet has not been properly caulked and sealed. The reglet should be caulked with a flexible non-shrinking caulk the full length of the reglet.

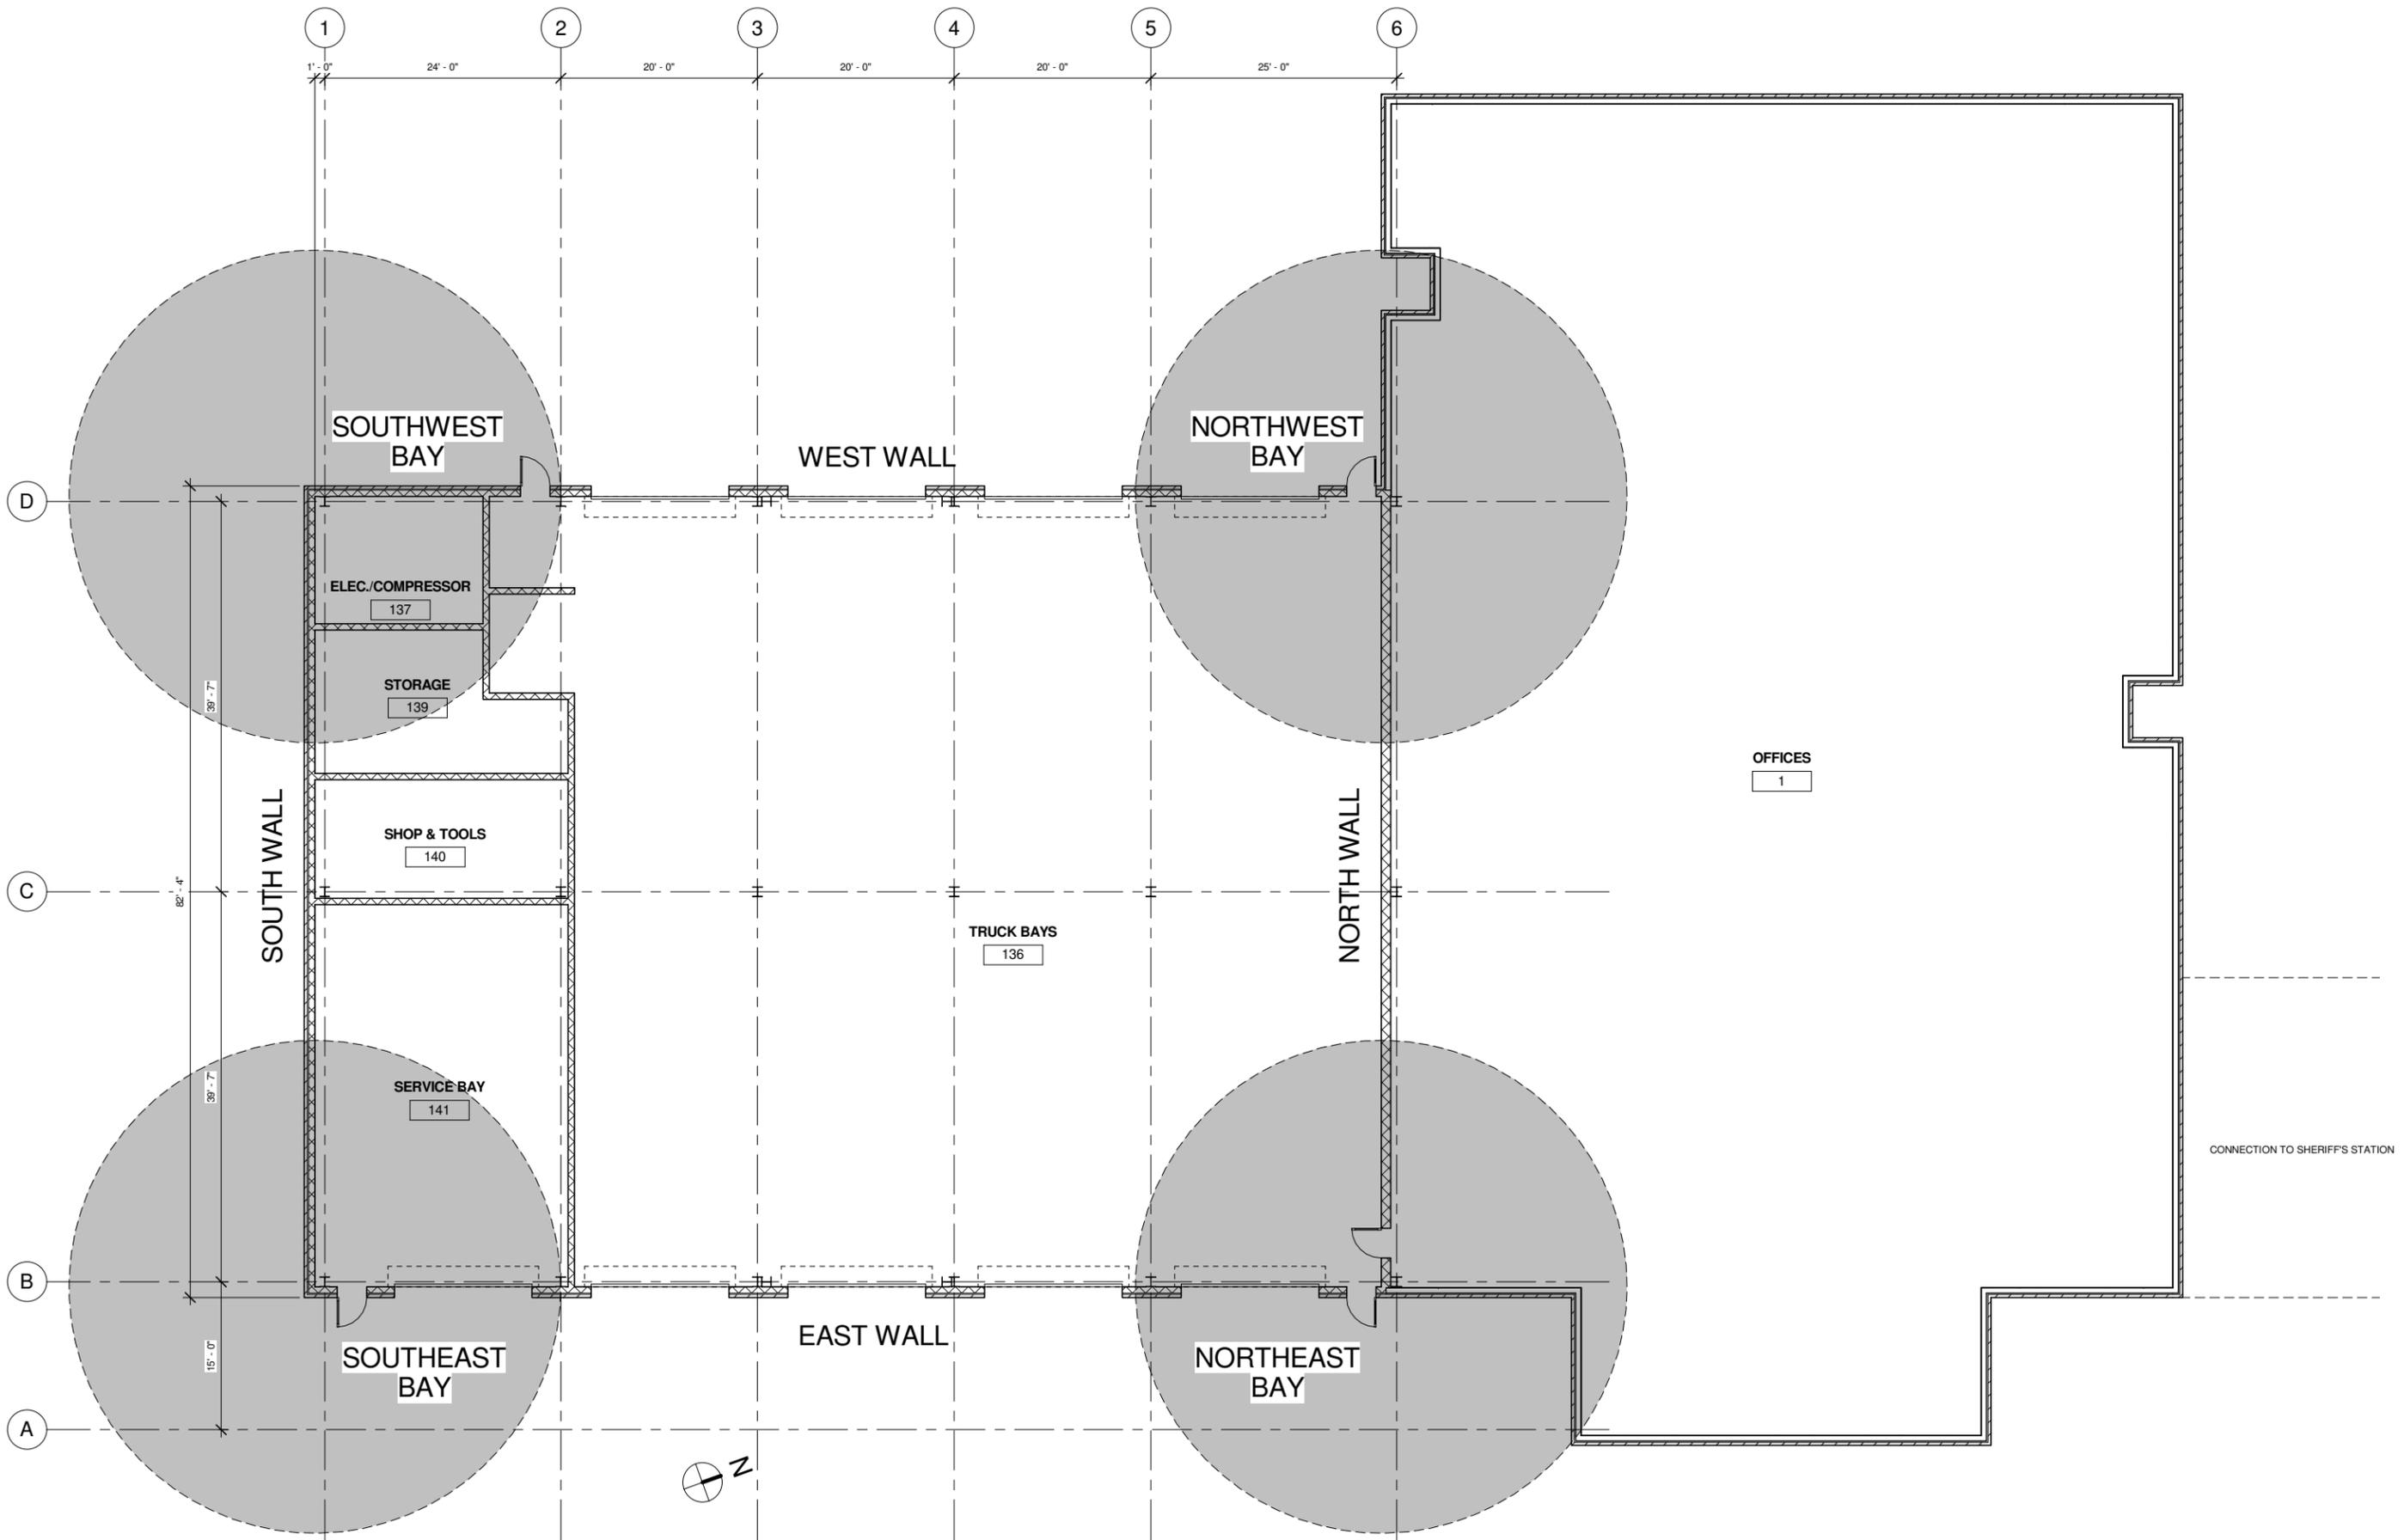
① FIRST FLOOR DIAGRAM OF EXISTING CONDITIONS
1/8" = 1'-0"

In the truck bay area, cracks in the masonry block walls and exterior brick veneer was observed at the following locations.

1. *Northeast corner at the front of the truck bay area:* Stepped cracking in the masonry block wall and brick veneer was observed above the right corner of the bay opening and extends downward to the northeast corner above the single door.

2. *Southeast corner at the front of the truck bay area:* Stepped cracking in the masonry block wall and brick veneer was observed above the left corner of the bay opening and extends downward to the southeast corner.

3. *Southwest corner at the rear of the truck bay area:* Stepped cracking in the upper portion of the masonry block wall and brick veneer was observed between the bay opening and the southwest corner.

4. *Northwest corner at the rear of the truck bay area:* Minor cracking in the upper portion of the masonry block wall and brick veneer was observed between the bay opening and the northwest corner.

5. *Split Face Masonry Veneer:* Minor cracks were noted along the split face 2'-8" high wainscoat at the base of the structure throughout. The vertical cracks in the masonry veneer are located just above grade and do not extend into the brick veneer above. Based on field observations and lack of evidence supporting differential settlement occurring at the structure, it appears the cracks in the masonry veneer are most likely attributed to the connection methods to the substrate and loading of the veneer above.

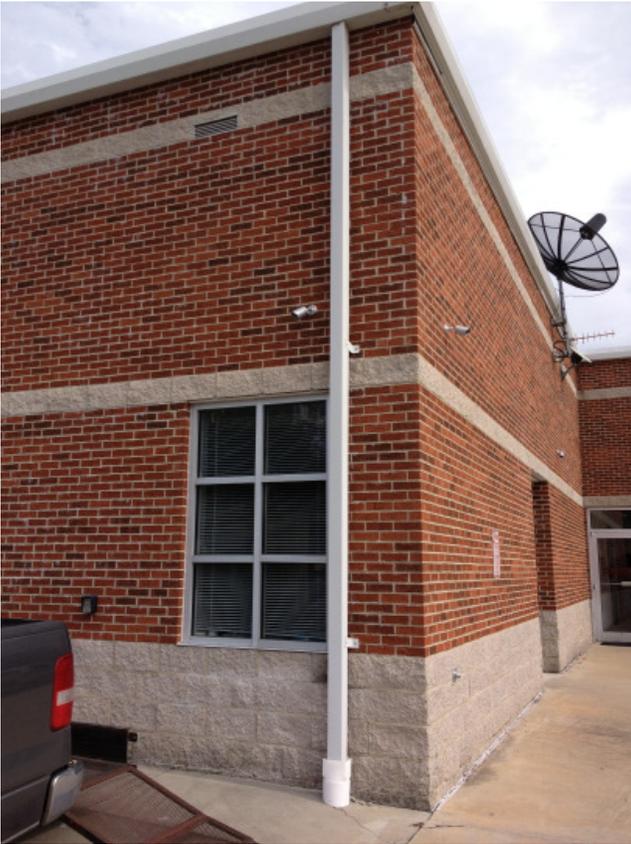
The west side of the office area of the Fire Station has significant efflorescence present on the surface of the masonry. See attached photographs in this section of the report for illustrations (photographs start at the south end of the affected west wall with photo 62 and move towards the north end of west wall and end with photo 69). It cannot be determined whether the efflorescence is a result of the construction process or has developed more recently. However, given the condition of the gutter and roof edge along the west wall, as well as the condition of the HVAC fresh air intake vents, it is more likely that the efflorescence is a result of ongoing water intrusion into the wall assembly. Once the water enters the wall assembly, its only way out is either through the weep holes above the windows and doors (a visual inspection did not reveal any weep holes at the base of the wall) and through migration of the moisture from the cavity to the face of the masonry via cracks, crevices, and the porosity of the masonry. The ongoing moisture intrusion into the wall will need to be corrected to prevent further efflorescence.

Photos 62: Southwest corner of Fire Station Offices. Note the white effluorescence on the brick, especially near top of wall.

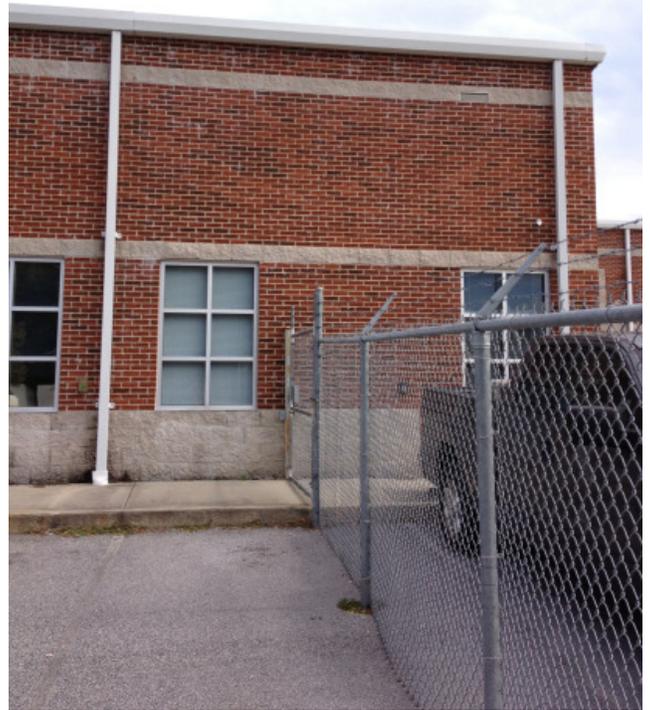
Photos 63: Wall of fire station offices. Note the white effluorescence on the brick.

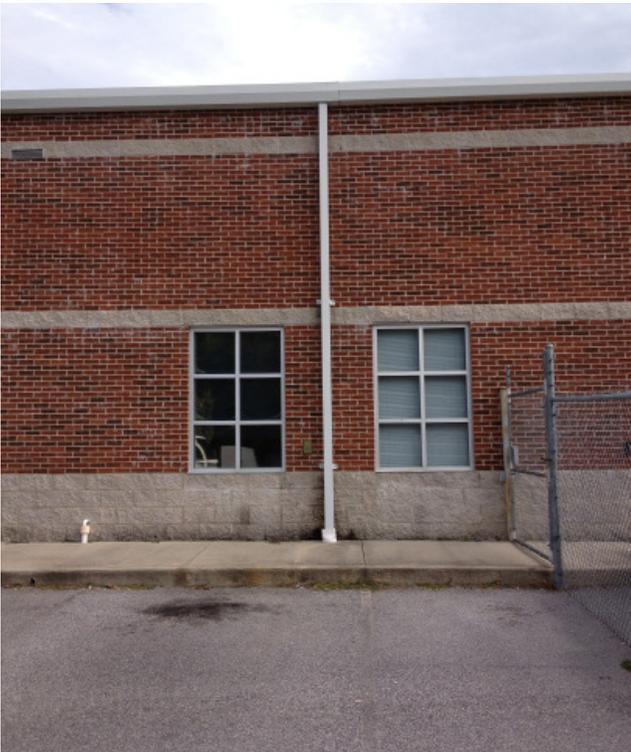
Photos 64: Effluorescence on brick is widespread on west wall of offices.

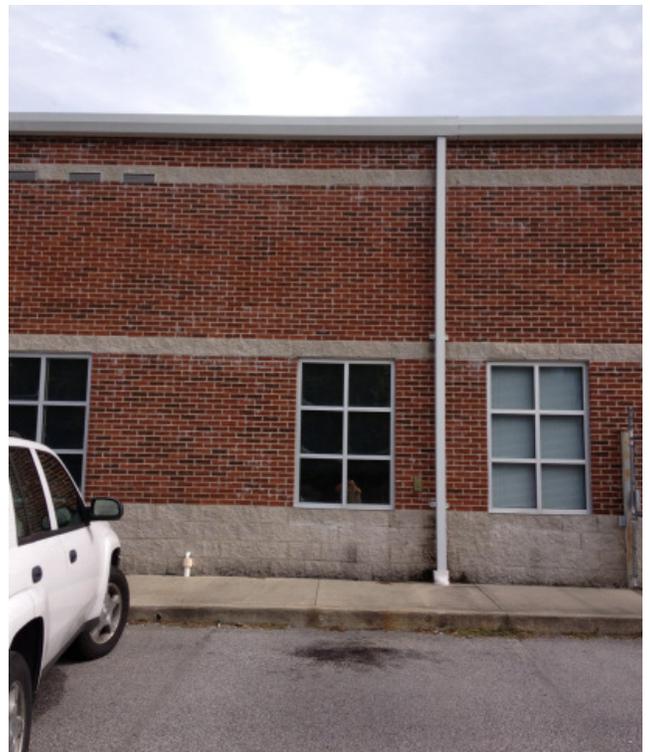
Photos 65: Effluorescence on brick is widespread on west wall of offices.

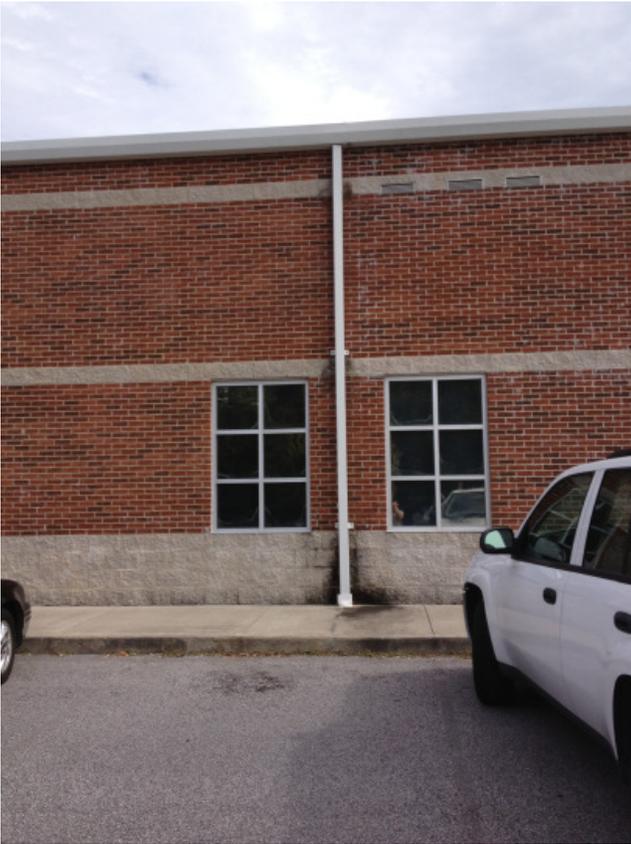
Photos 66: Effluorecence on brick is widespread on west wall of offices.

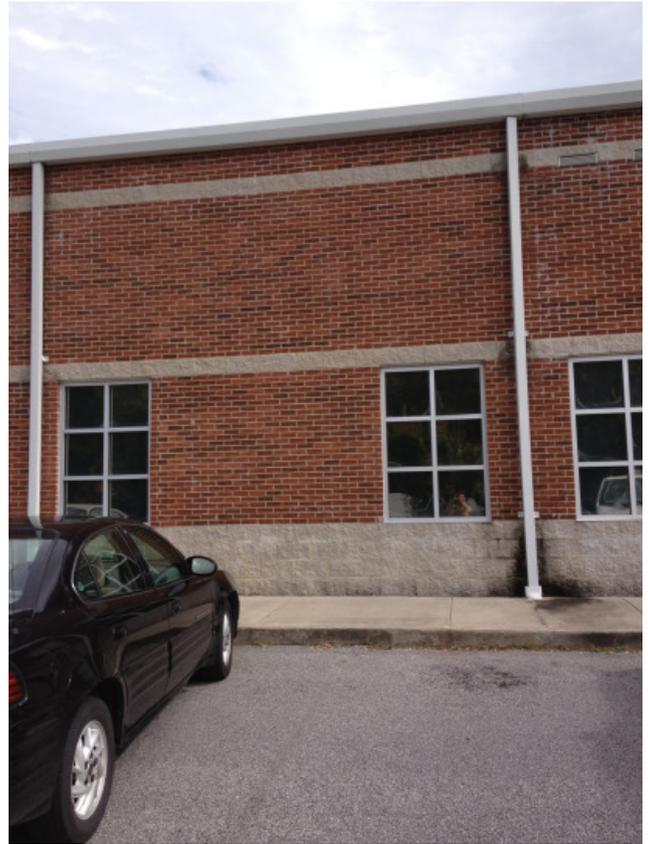
Photos 67: Effluorecence on brick is widespread on west wall of offices.

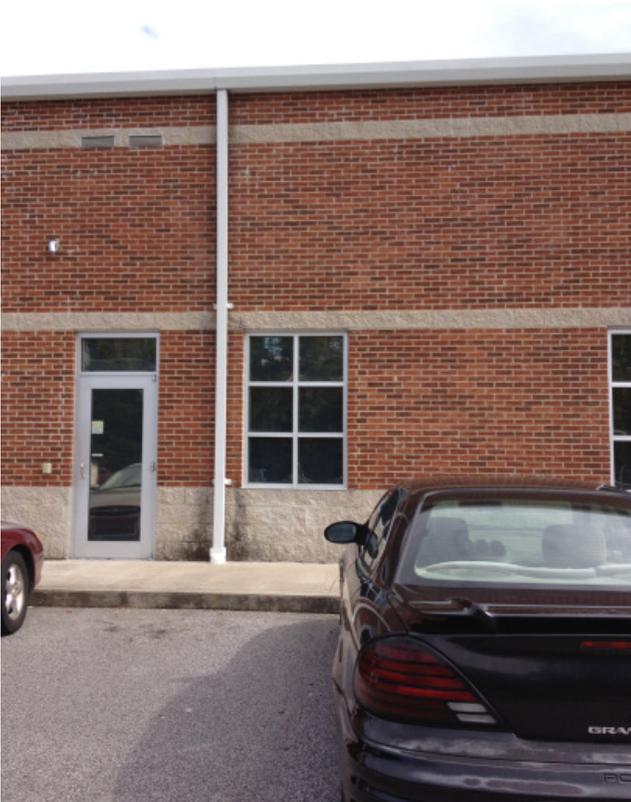
Photos 68: Effluorecence on brick is widespread on west wall of offices.

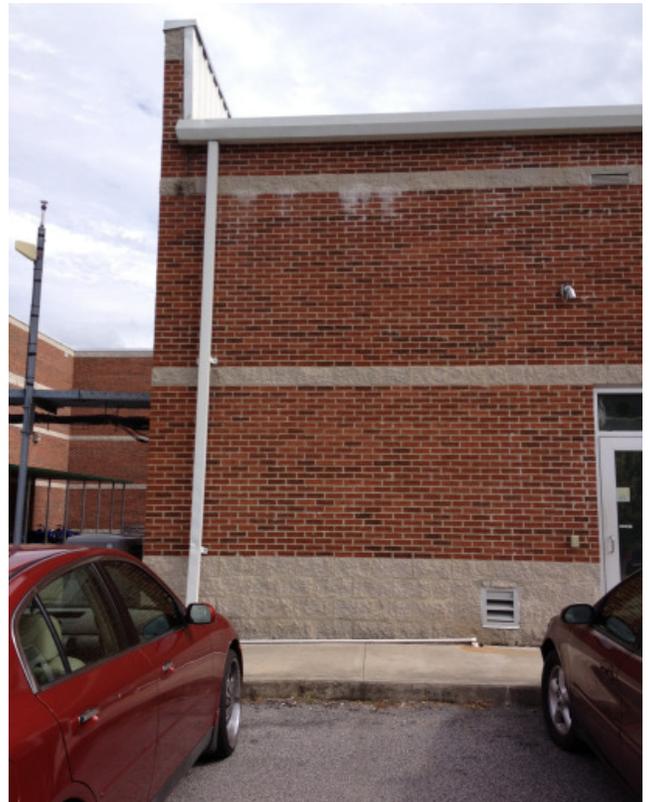
Photos 69: Effluorecence on brick is widespread on west wall of offices. Photo is at northwest corner.
